TRANSMITTAL MEMORANDUM

RE: **Contract No. 16-16 – Planning and Design of Port Improvements, Moffatt & Nichol**

CONDITION ASSESSMENT REPORT

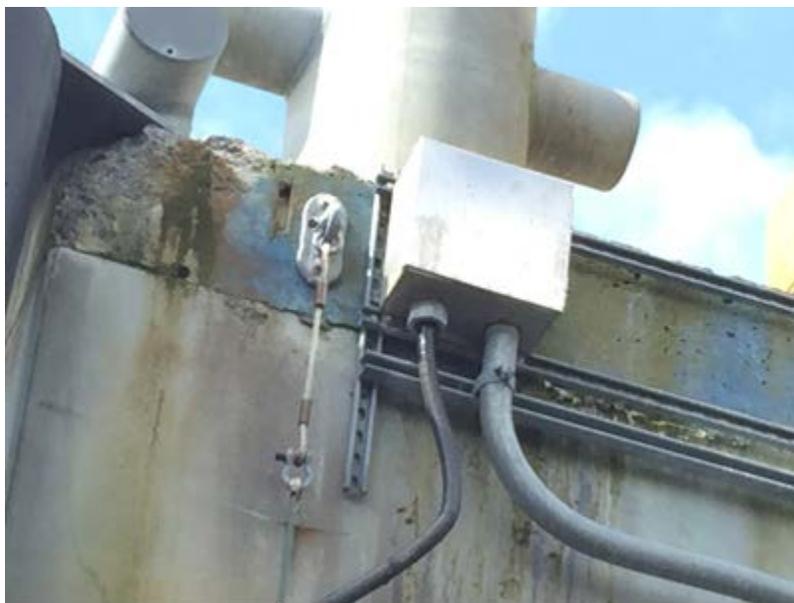
Figure 32: Damaged Corner

The south east corner of the dock shows signs of impact damage. The damaged concrete is behind a steel fender pile, apparently installed to protect the corner of the dock. The design drawings show 3 timber fenders piling as corner protection at this location. It's possible that the timber fender piling were damaged in the same event that damaged the dock corner, and that the steel fender piling was installed as a replacement. The damaged concrete should be patched to prevent corrosion of the reinforcing steel.

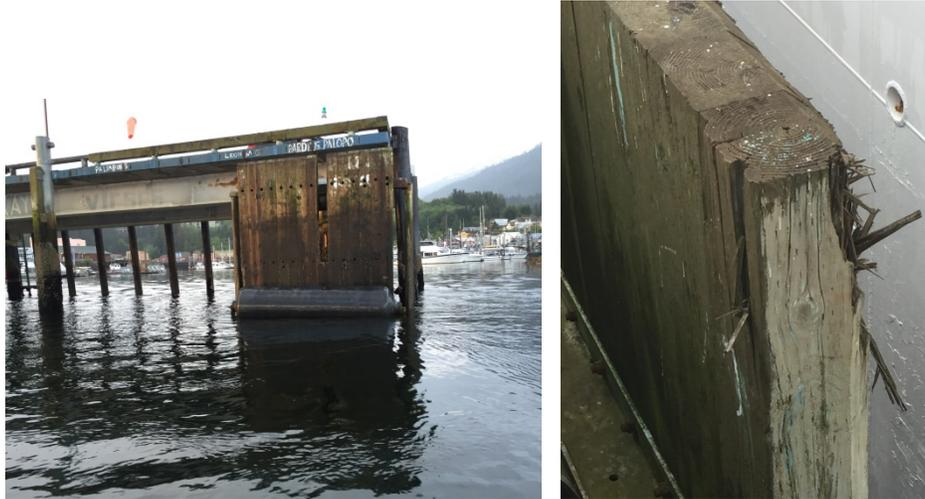
Figure 38: damaged Fender Planks

Damage was observed on the timber fender panel planks. Damage was more prevalent where the planks cantilever past the steel wale that connects the panel to the circular fender units. The damage generally consists of moderate cracks, splits, and abrasions in the planks. One Plank on the southern-most dolphin was found to be fractured where it bolts to the wale.

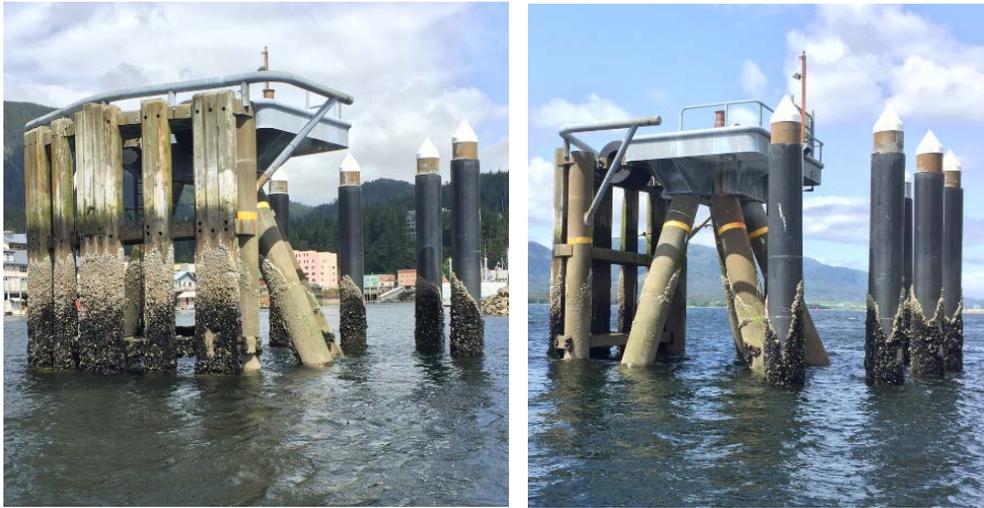
Figure 40: Damaged Bullrail Sections

The underwater portion of the dolphin was not inspected. It is unknown if the dolphin has any cathodic protection installed, but it is assumed to be un-protected as the 2005 Berth 1 Rehabilitation and Upgrade drawings make no mention of this dolphin. As the dolphin ages, the galvanized coating will continue to be consumed until it is no longer sufficient to protect the steel piling, at which point, section loss and reduced structural capacity of the steel piling will occur.

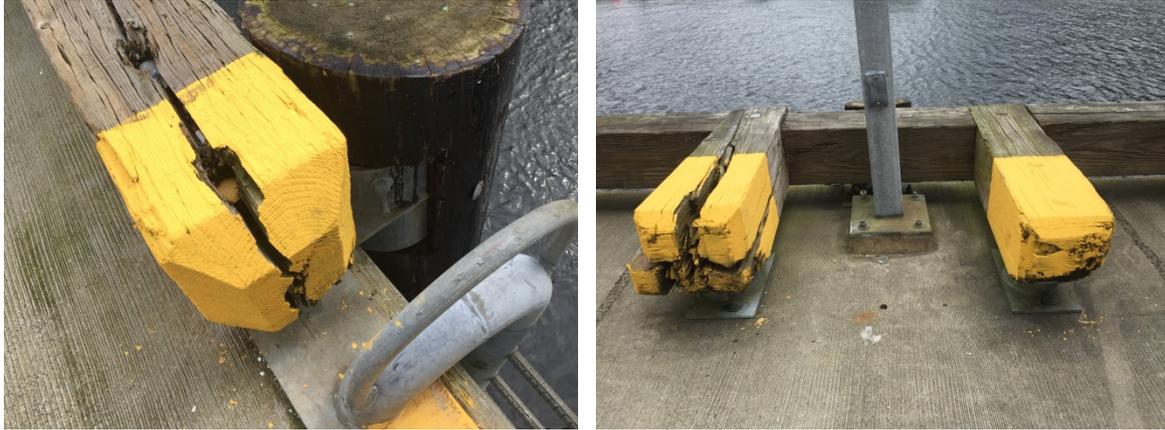
Figure 41: Damaged Bullrail Sections

The timber bullrail on Berth 1 and 2 is in overall satisfactory condition with areas of localized damage. The bullrail damage consists of splits, checks, and abrasion. Damage is most common at the ends of bullrail members, particularly at the openings for the fender transition plates. The damage typically appears to effect less than 10% of the cross section of the bullrail at most locations. As the bullrail is not used for line handling operations, the damage does not appear to significantly impact its functionality and is mostly detrimental in terms of appearance. There are however, several sections that are severely damaged and should be replaced. On the south end of the dock, a section of bullrail is severely cracked through its entire section at the gap in the bullrail for the safety ladder. At pile cap grid 19, the bullrail section that protects the light pole is severely damaged from an apparent impact. During the inspection, it was noted that many of the bullrail mounting assemblies appeared to have been re-drilled, presumably during construction to accommodate fastener placement.

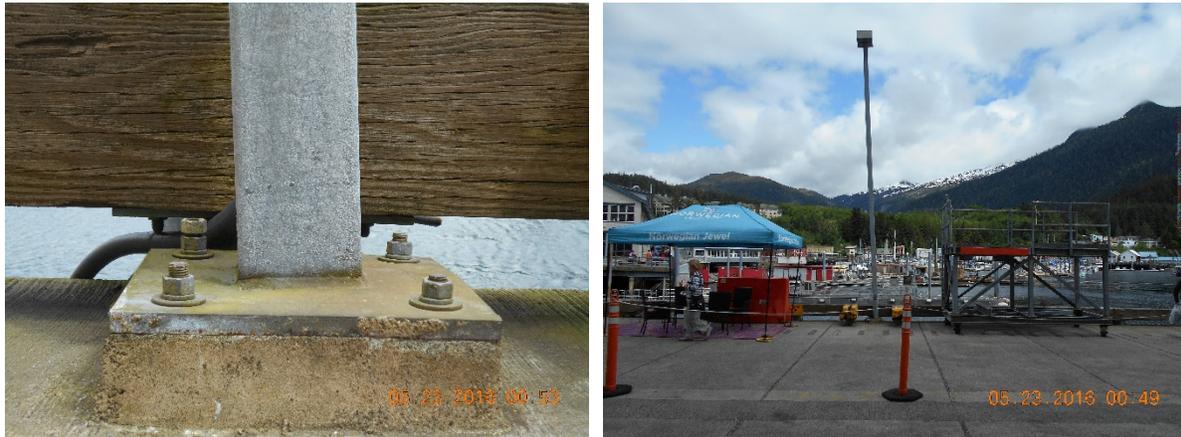
Figure 47: Damaged Light Pole Bases

The inspection included the structural elements of the lighting system. The light poles are generally showing signs of minor coating loss and minor corrosion. The light pole at pile bent 19 was observed to lean moderately, apparently from an impact. Upon closer inspection, it was noted that the welds at the base of the light pole were cracked. It is possible that under a high wind event or in the case of even a modest impact, the light pole could become unstable and collapse.

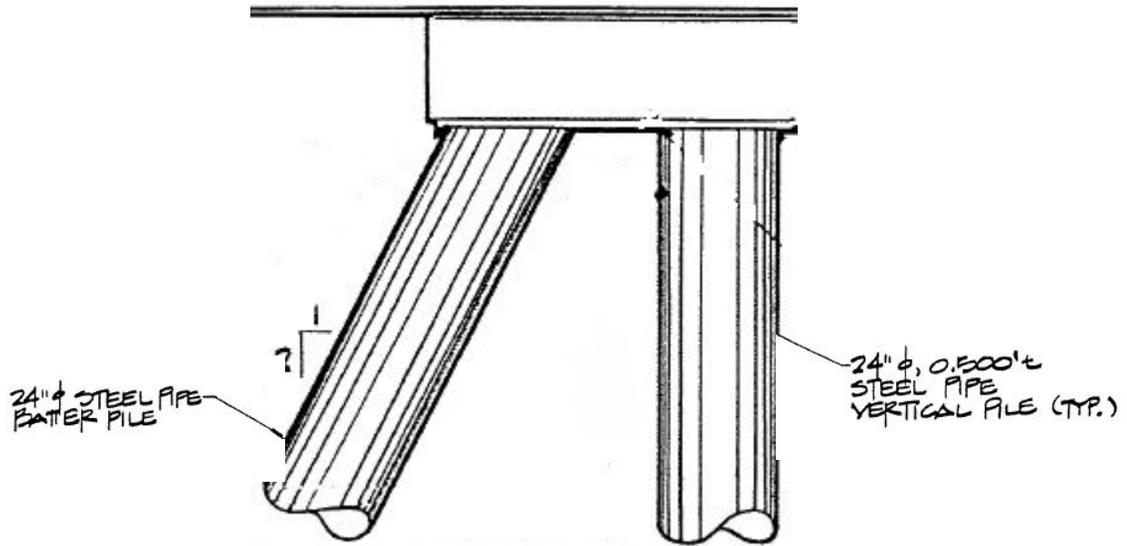
Figure 2.4, Typical Plumb/Batter Pile

Minor corrosion and pitting were noted on some of the vertical and batter piles. Figure 2.4 shows typical piles. The original design drawings specified steel pipe piles conforming to ASTM A252 Gr. 3 or API 5LX – 52. Based on those specifications, the measured wall thickness of each pile may be less than the nominal thickness by 12.5% or .125 x the wall thickness, to account for production tolerances. Of the piles inspected, none were observed to have a reduction in wall thickness of less than the minimum specified tolerance. This indicates that corrosion has not impacted the as designed structural capacity of the piles.

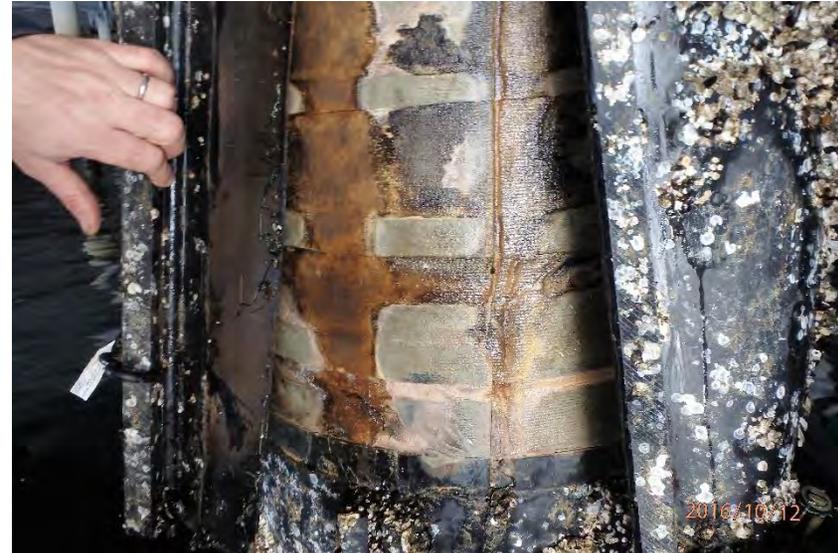
As-found condition of piling tape

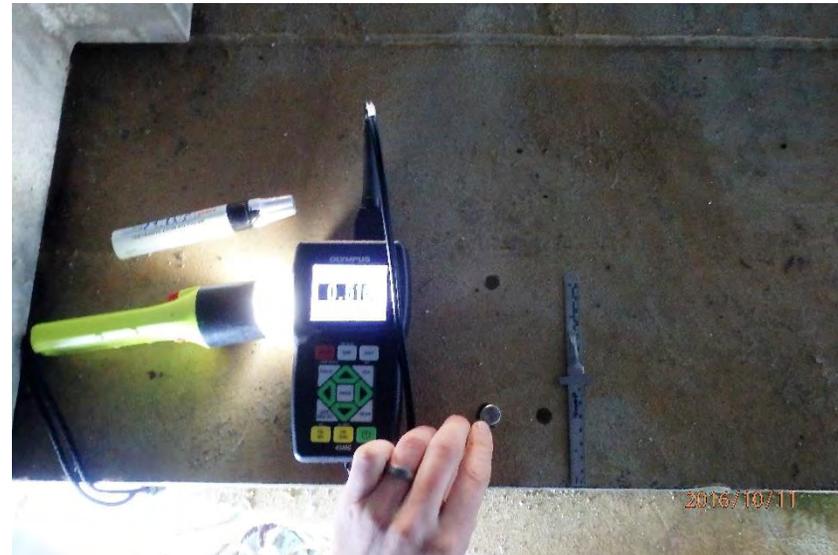
Bent 3 piling cap ultrasonic thickness testing (515 mils min)

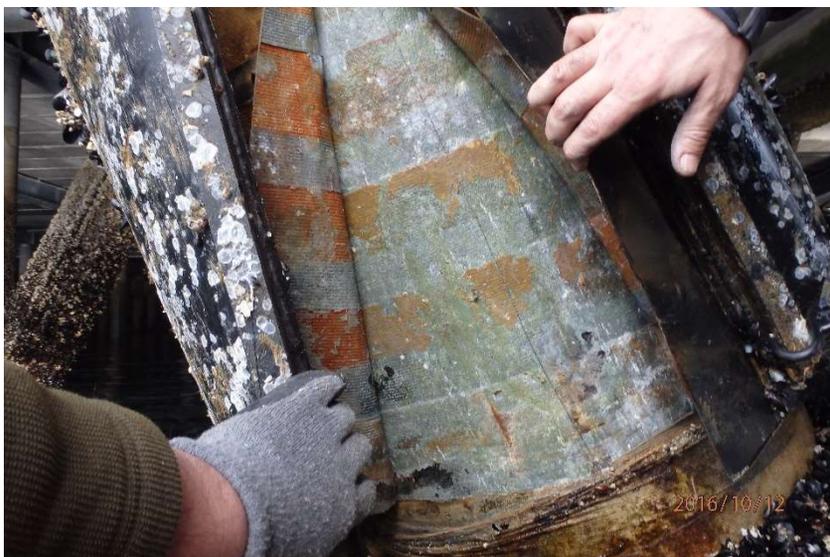
Piling surface beneath tape found in good condition

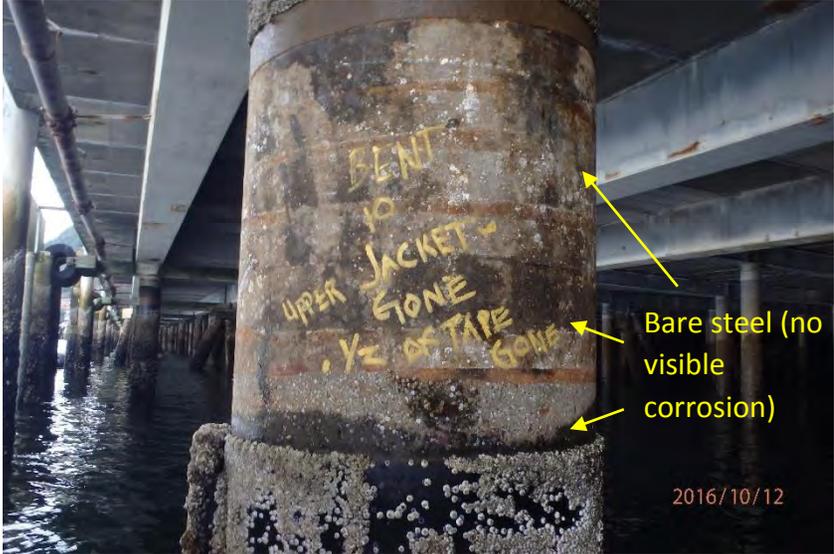
Piling with missing or slipped upper jacket

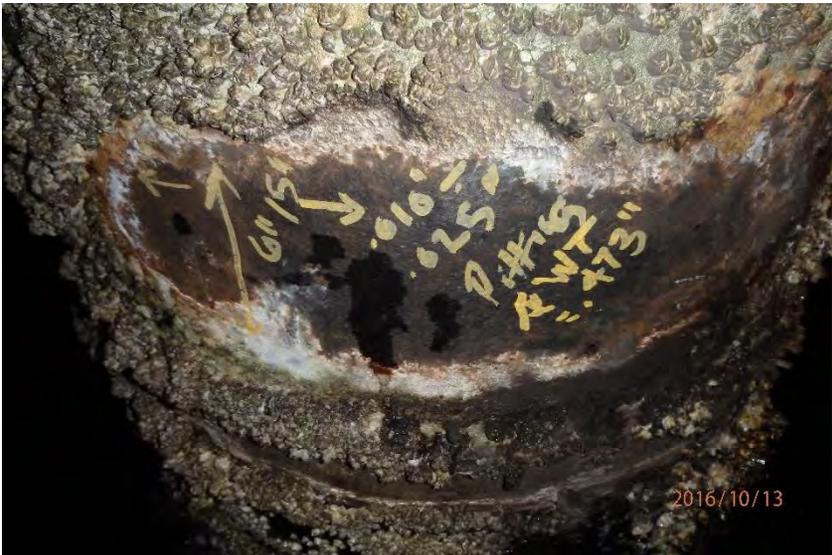
Pile 1, corrosion above pile jacket. (UT Location 1)

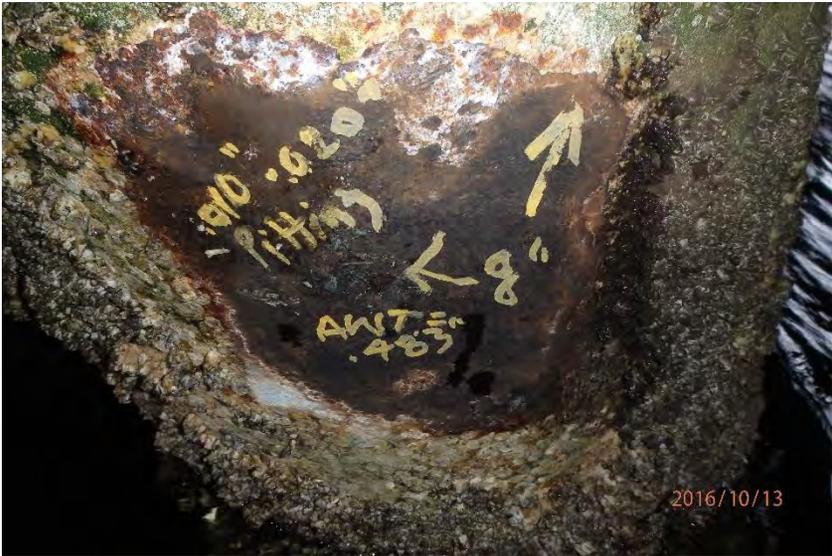
Pile 2, corrosion above pile jacket (UT Location 2)

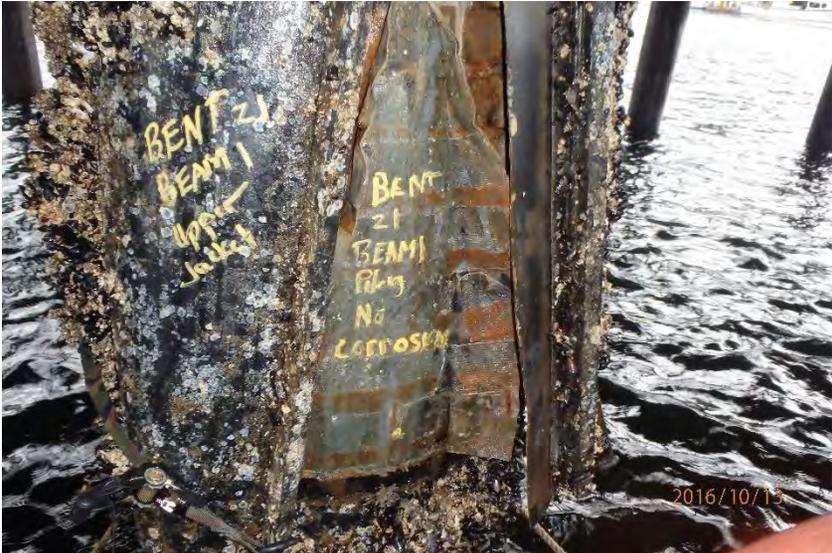
Piling condition at pile sleeve.

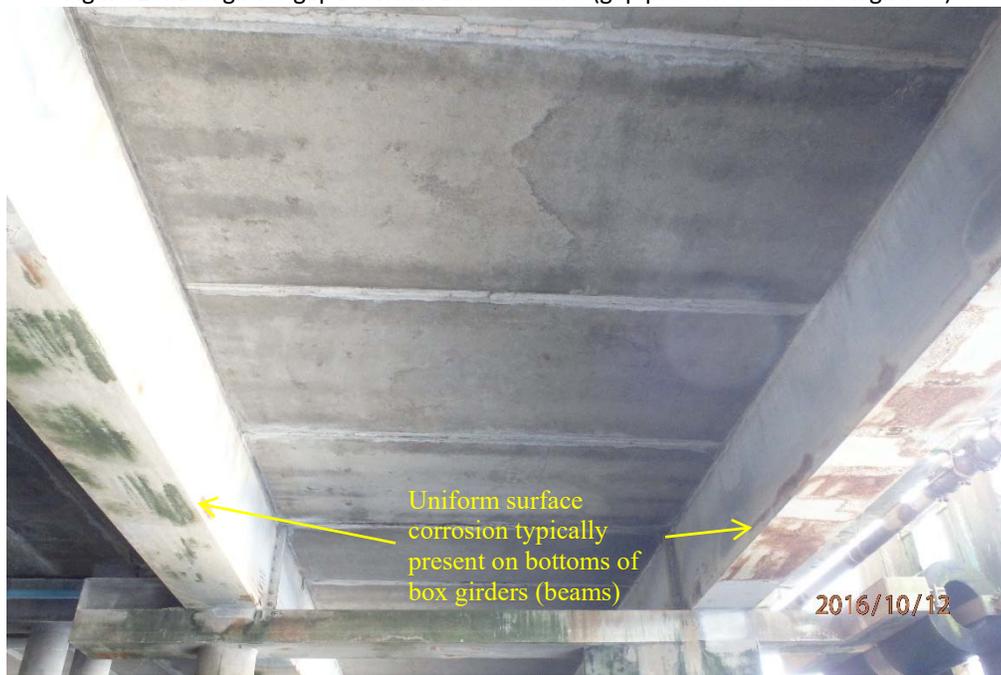
Figure 14: Typical underside of concrete deck panel and girder bottom sides with surface corrosion

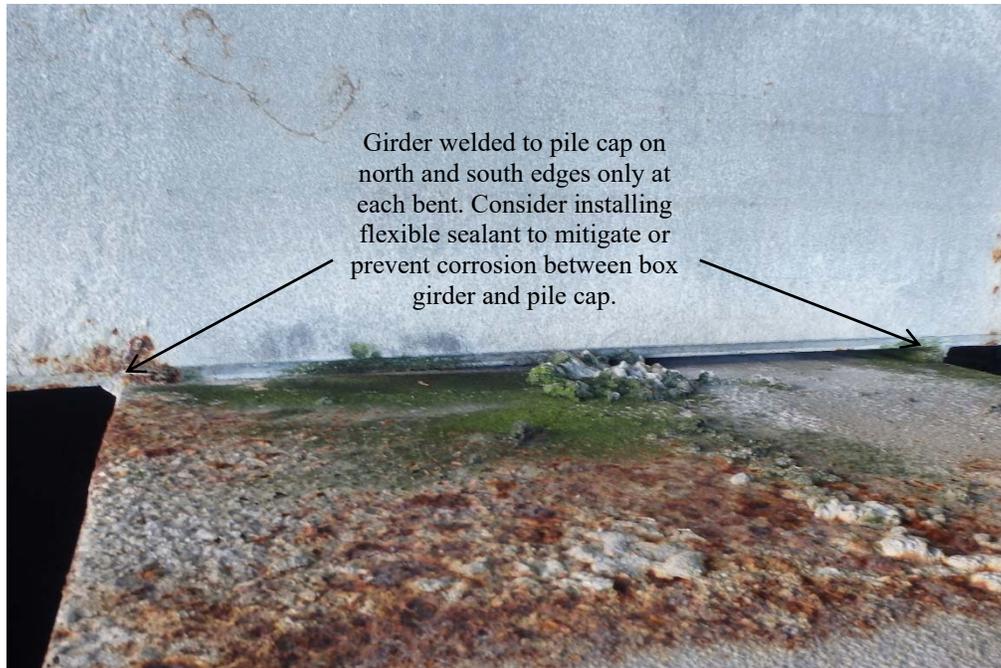
Figure 15: Typical box girder/pile cap interface with gap

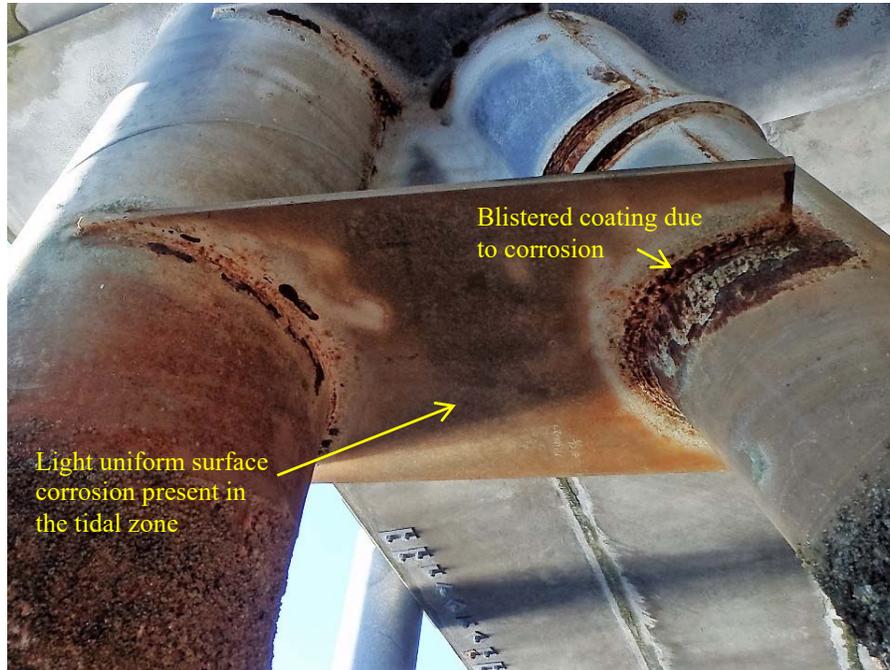
Figure 17: Berth 3 typical pile surfaces with uniform surface corrosion and coating blistering

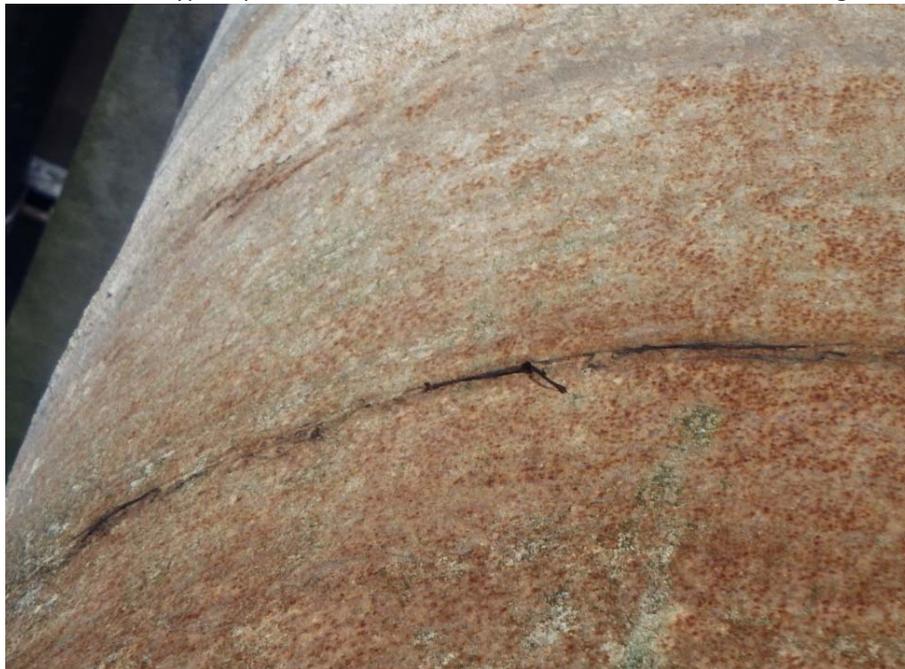
Figure 18: Close-up of typical light surface corrosion on Berth 3 pile
