National Transportation Safety Board Aviation Accident Factual Report

Location:	Metlakatla, Alaska	Accident Number:	ANC19FA019
Date & Time:	May 20, 2019, 15:56 Local	Registration:	N67667
Aircraft:	De Havilland DHC 2	Aircraft Damage:	Substantial
Defining Event:	Loss of control on ground	Injuries:	2 Fatal
Flight Conducted Under:	Part 135: Air taxi & commuter - Scheduled

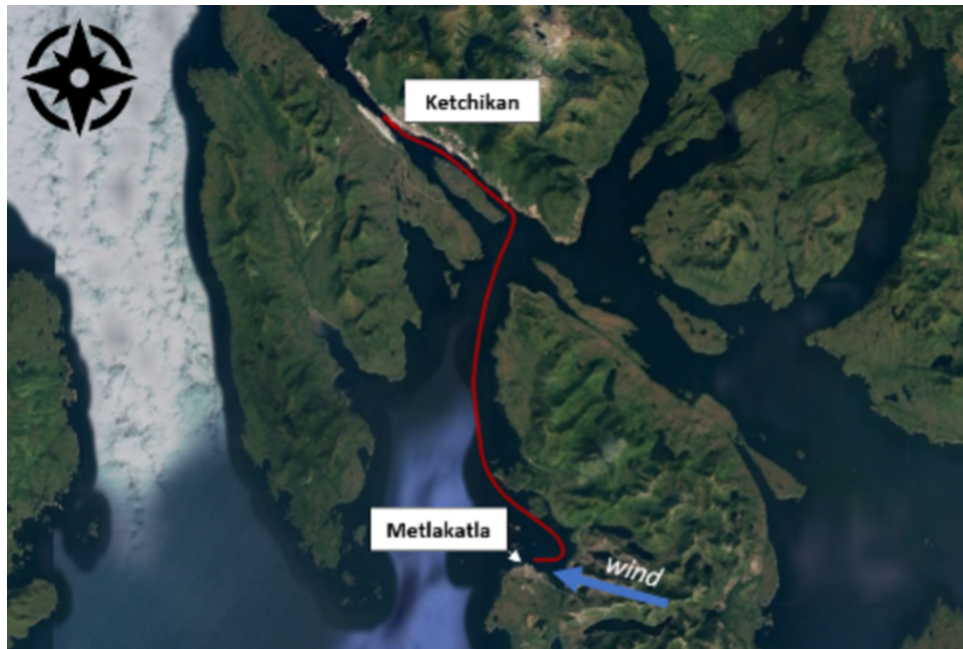
A review of GPS track data revealed that the airplane departed 5KE about 1543 and traveled southeast over an area known as the Tongass Narrows, then south to Metlakatla Harbor at an altitude of about 800 ft. The airplane made a right turn to a 240° (magnetic) heading in the southern portion of the harbor then the data ended. (See figure 1.)

Figure 1. Flight track (red) and wind observation.

Calculated wind velocity from the one of the airplane's IDUs indicated that the wind during takeoff was from 090° (magnetic) at 15 knots. As the airplane climbed through an indicated altitude of 750 ft, the wind shifted to 290° at 9 knots and remained from the west throughout the en route portion of the flight and the initial segment of the visual approach to the destination. As the airplane descended and turned onto its final approach path of about 242°, the wind shifted from 253° at 6 knots, becoming southerly at 2 knots, then from 083° at 8 knots over the 30 seconds before the airplane landed. This was a shift of 170° and 14 knots, which resulted in a change from a 6-knot headwind to a 7-knot tailwind, and a 2-knot right crosswind to a 3-knot left crosswind component during the approach and landing sequence. According to the manufacturer's operating handbook, the values can contain errors and wind peaks and gusts are not calculated.

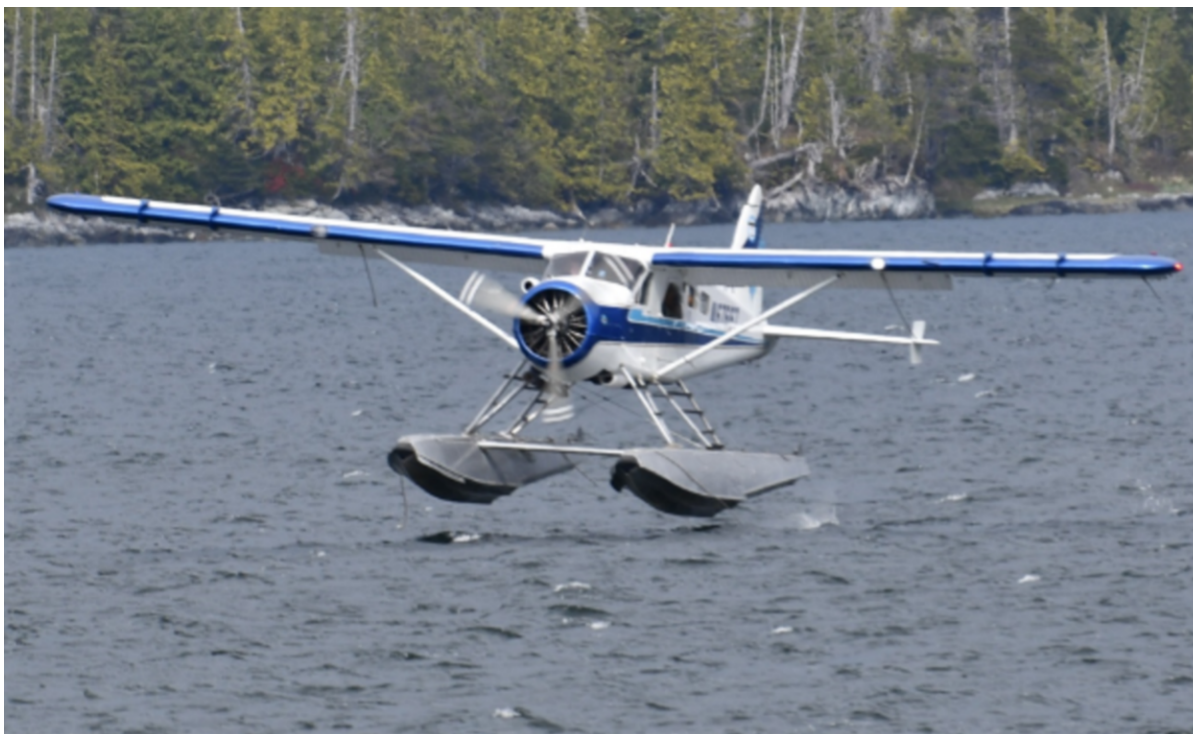
There were three witnesses to the airplane's approach and landing. One of the witnesses, who was taking photographs near the pier, reported that the wind appeared to be pushing the airplane right during touchdown and that the airplane was drifting right as the floats contacted the water. After the airplane skipped once or twice, the left wing "dipped" down, then the right wing "dipped down and dug into the water," which resulted in the airplane nosing over and the right wing separating.

Another witness, who was in a boat, stated that the airplane hit the water hard and he saw the right float "dig into the water" before the airplane turned over as it pivoted around. The third witness stated that the airplane appeared to be "teetering back and forth" and a gust of wind appeared to push the tail upward as the right wing dropped down and the airplane nosed over. She stated that the wind was from the southeast with gusts of 13 mph and the water was less than choppy. The inverted airplane partially sank with the front fuselage and cockpit under water. (See figures 2 and 3.)

Figure 2. The airplane during the landing sequence after a brief touchdown on the left float. (Source: Nicholas King.)

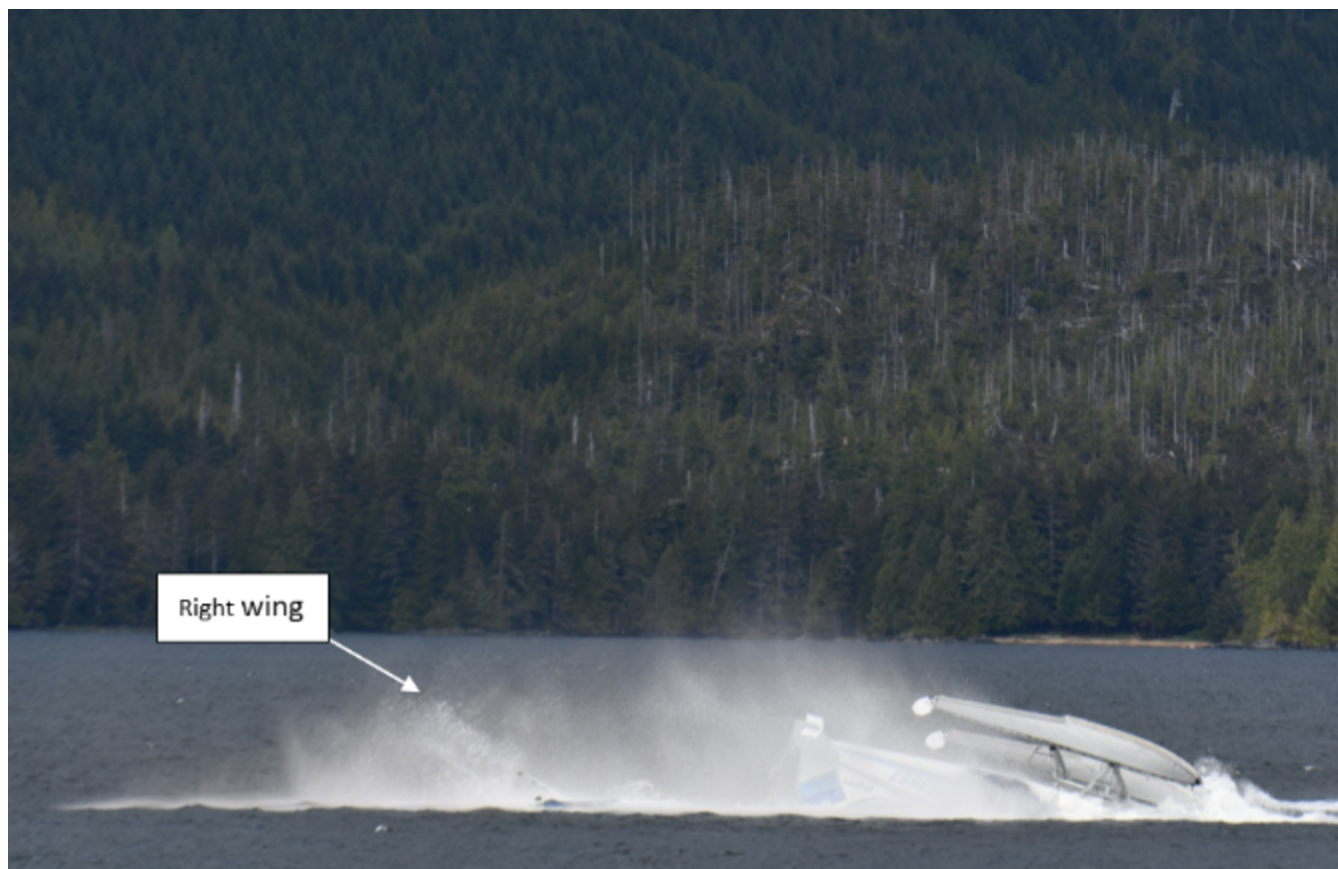
Figure 3. The airplane inverted after the accident. (Source: Nicholas King.)

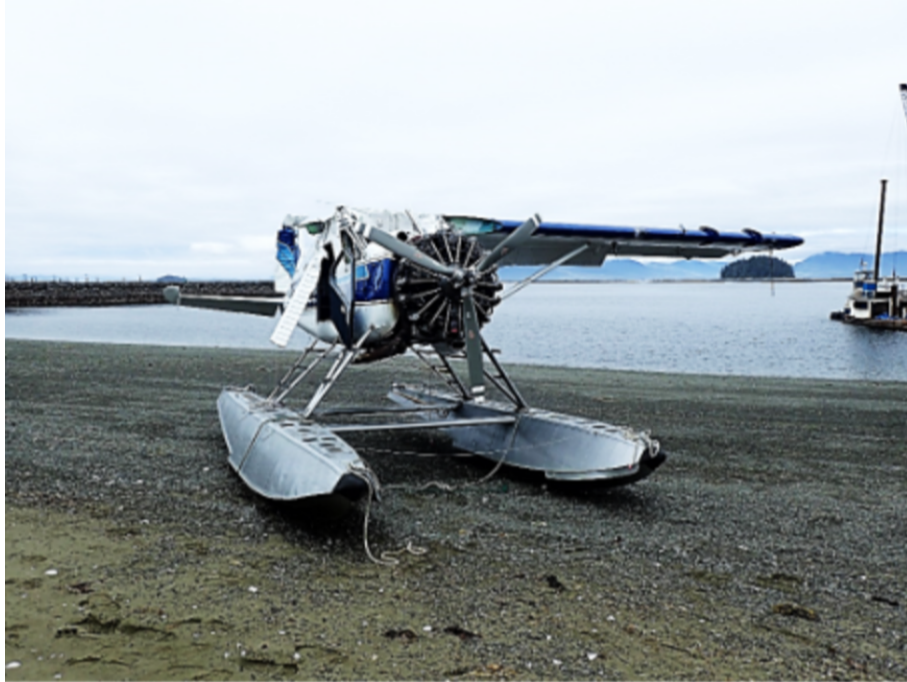
The airplane came to rest inverted on an easterly heading with the right wing separated and floating about 15 ft to the west. First responders stated that the passenger's front right seat was removed to facilitate rescue and subsequently sank in the bay. A postaccident examination of the airframe revealed that all other major components were attached. The floats, float struts, spreader bars, and control cables were intact. The right and left sea rudders were each fractured at the lower welds and exhibited minor bending deformation. (See figure 5.)

Figure 5. The airplane after recovery from the harbor.

The right wing forward fuselage attachment lug was fractured and exhibited dull, dimpled fracture surfaces; the rear attachment was fractured and deformed rearward. The right flap was attached to the fuselage by the inboard bracket, with the control rod fractured. An indentation on the right side of the fuselage was consistent with the right flap in the land position during impact. The left wing, aileron and flap were intact and attached. The left flap was extended to the land position. The cockpit flap position indicator was slightly above the land position. Flight control continuity was established from the pilot's control wheel to the left aileron and right wing aileron pulley and the elevator. Rudder and elevator trim cable continuity was established to the aft trim tabs; however, the trim cables could not be moved due to airframe deformation and cable constriction forward of the cockpit upper trim wheels.

The forward fuselage above the cockpit was fractured at the upper center windshield brace, and the forward upper skin was deformed inward and downward into the left side of the cockpit. The left forward door (pilot's) was secure in place with minor deformation. The right forward door was secure in place with mild deformation and the door opening mechanism worked properly. The right cabin door was open and attached partially by the forward lower attachment. The opening mechanism worked properly. Exit placards were in place.

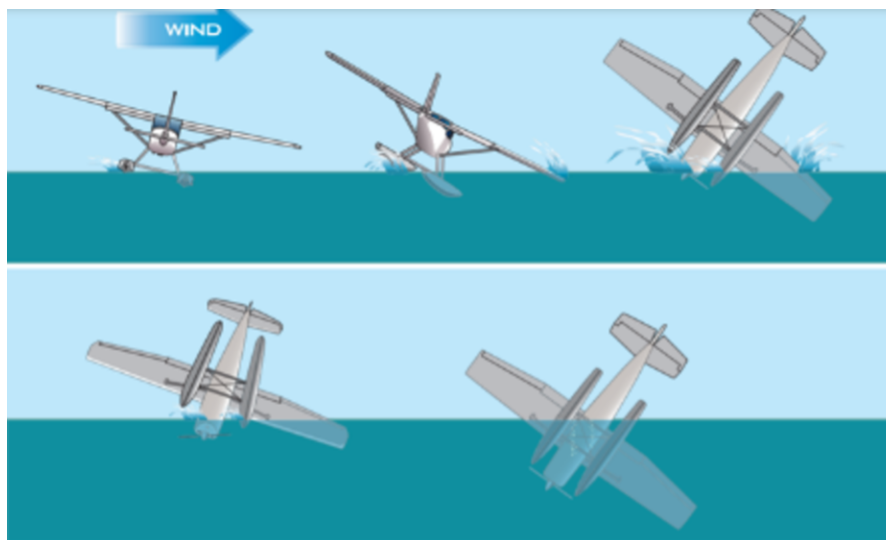
If the seaplane touches down while drifting sideways, the sudden resistance as the floats contact the water creates a skidding force that tends to push the downwind float deeper into the water. The combination of the skidding force, wind, and weathervaning as the seaplane slows down can lead to a loss of directional control and a waterloop. If the downwind float submerges and the wingtip contacts the water when the seaplane is moving at a significant speed, the seaplane could flip over. See figure 6.3. (Figure 6.)

Figure 6. Figure 6-3 in the FAA Seaplane Handbook illustrating the hazard of landing while drifting sideways in a crosswind at significant speed.
