# National Transportation Safety Board Aviation Accident Preliminary Report

<b>Location:</b>	Salish Sea, WA	<b>Accident Number:</b>	WPR21LA097
<b>Date &amp; Time:</b>	January 26, 2021, 16:40 Local	<b>Registration:</b>	N9114A
<b>Aircraft:</b>	Cessna 170A	<b>Injuries:</b>	1 Fatal
<b>Flight Conducted Under:</b>	Part 91: General aviation - Personal

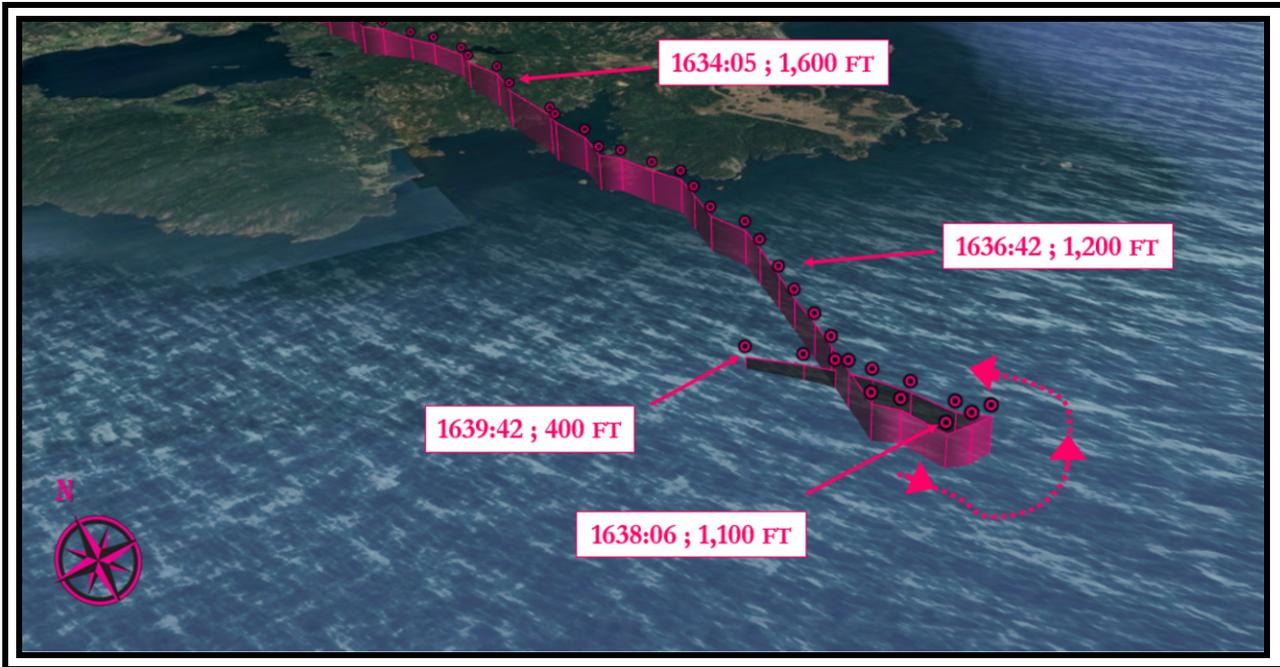
Picture 1: Last Radar Returns

A review of the radar data revealed that the targets were on a southerly track, reaching the edge of the northly land mass at 1634. The radar hits continued south for about 5.4 nm at an altitude of about 1,200 ft. At 1638:06 the returns deviated from the southerly direction and were consistent with the airplane reversing course and heading north-northeast. The returns from the turn to the last hit indicated a decreasing airspeed and a gradual decent from 1,200 to 400 ft (see Picture 1).

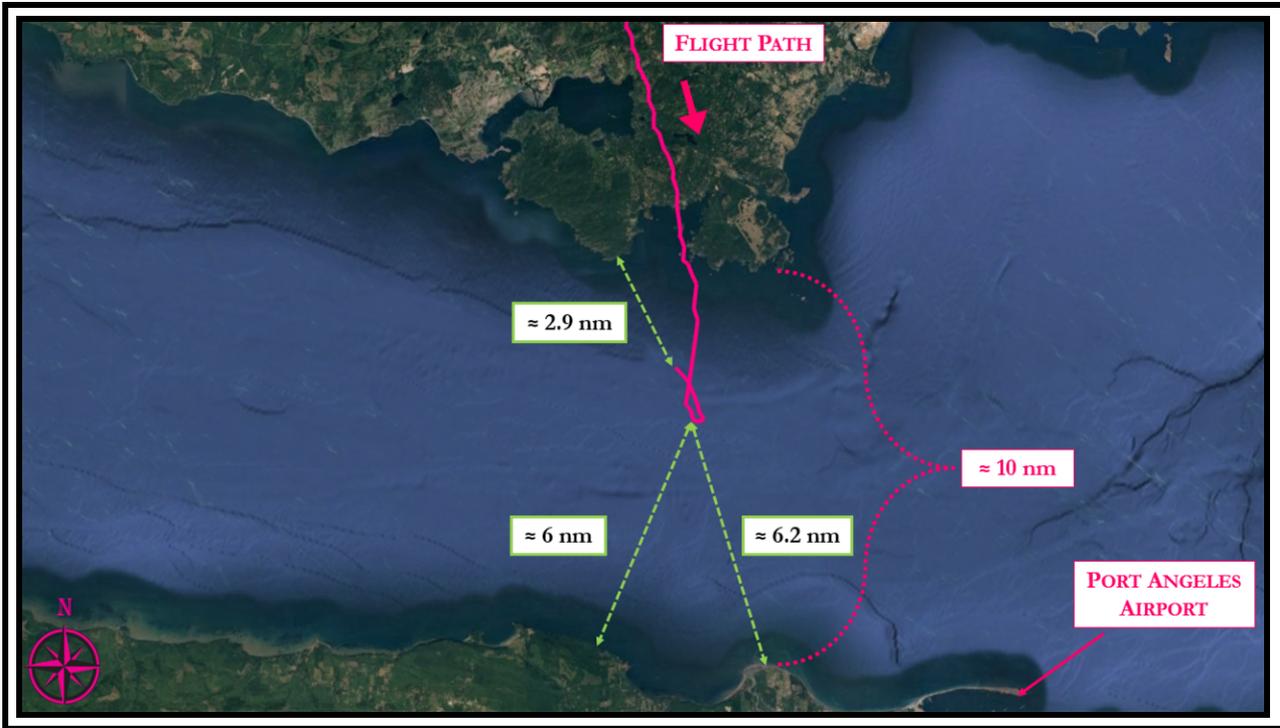
Picture 2: Radar Track in reference to Land.

The radar hit the farthest south, was about 6 nm from land to the south and 4 nm from land to the north. The last radar return was 2.9 nm from the closet land (see Picture 2). The pilot sent a picture to his mother about 1637 which showed a marine vessel towing a barge in the water below his location. The pilot broadcast a mayday call over the Port Angeles UNICOM frequency at 1638:47. He stated that he was out in the middle of the water and was ditching by a boat that was towing a barge.
