# Island to Island:

## An Alaskan High-Voltage Submarine Cable Failure

A utility serving several isolated Alaskan communities works to repair a severed power lifeline to the mainland.

By **ROBERT SIEDMAN**, Southeast Alaska Power Agency

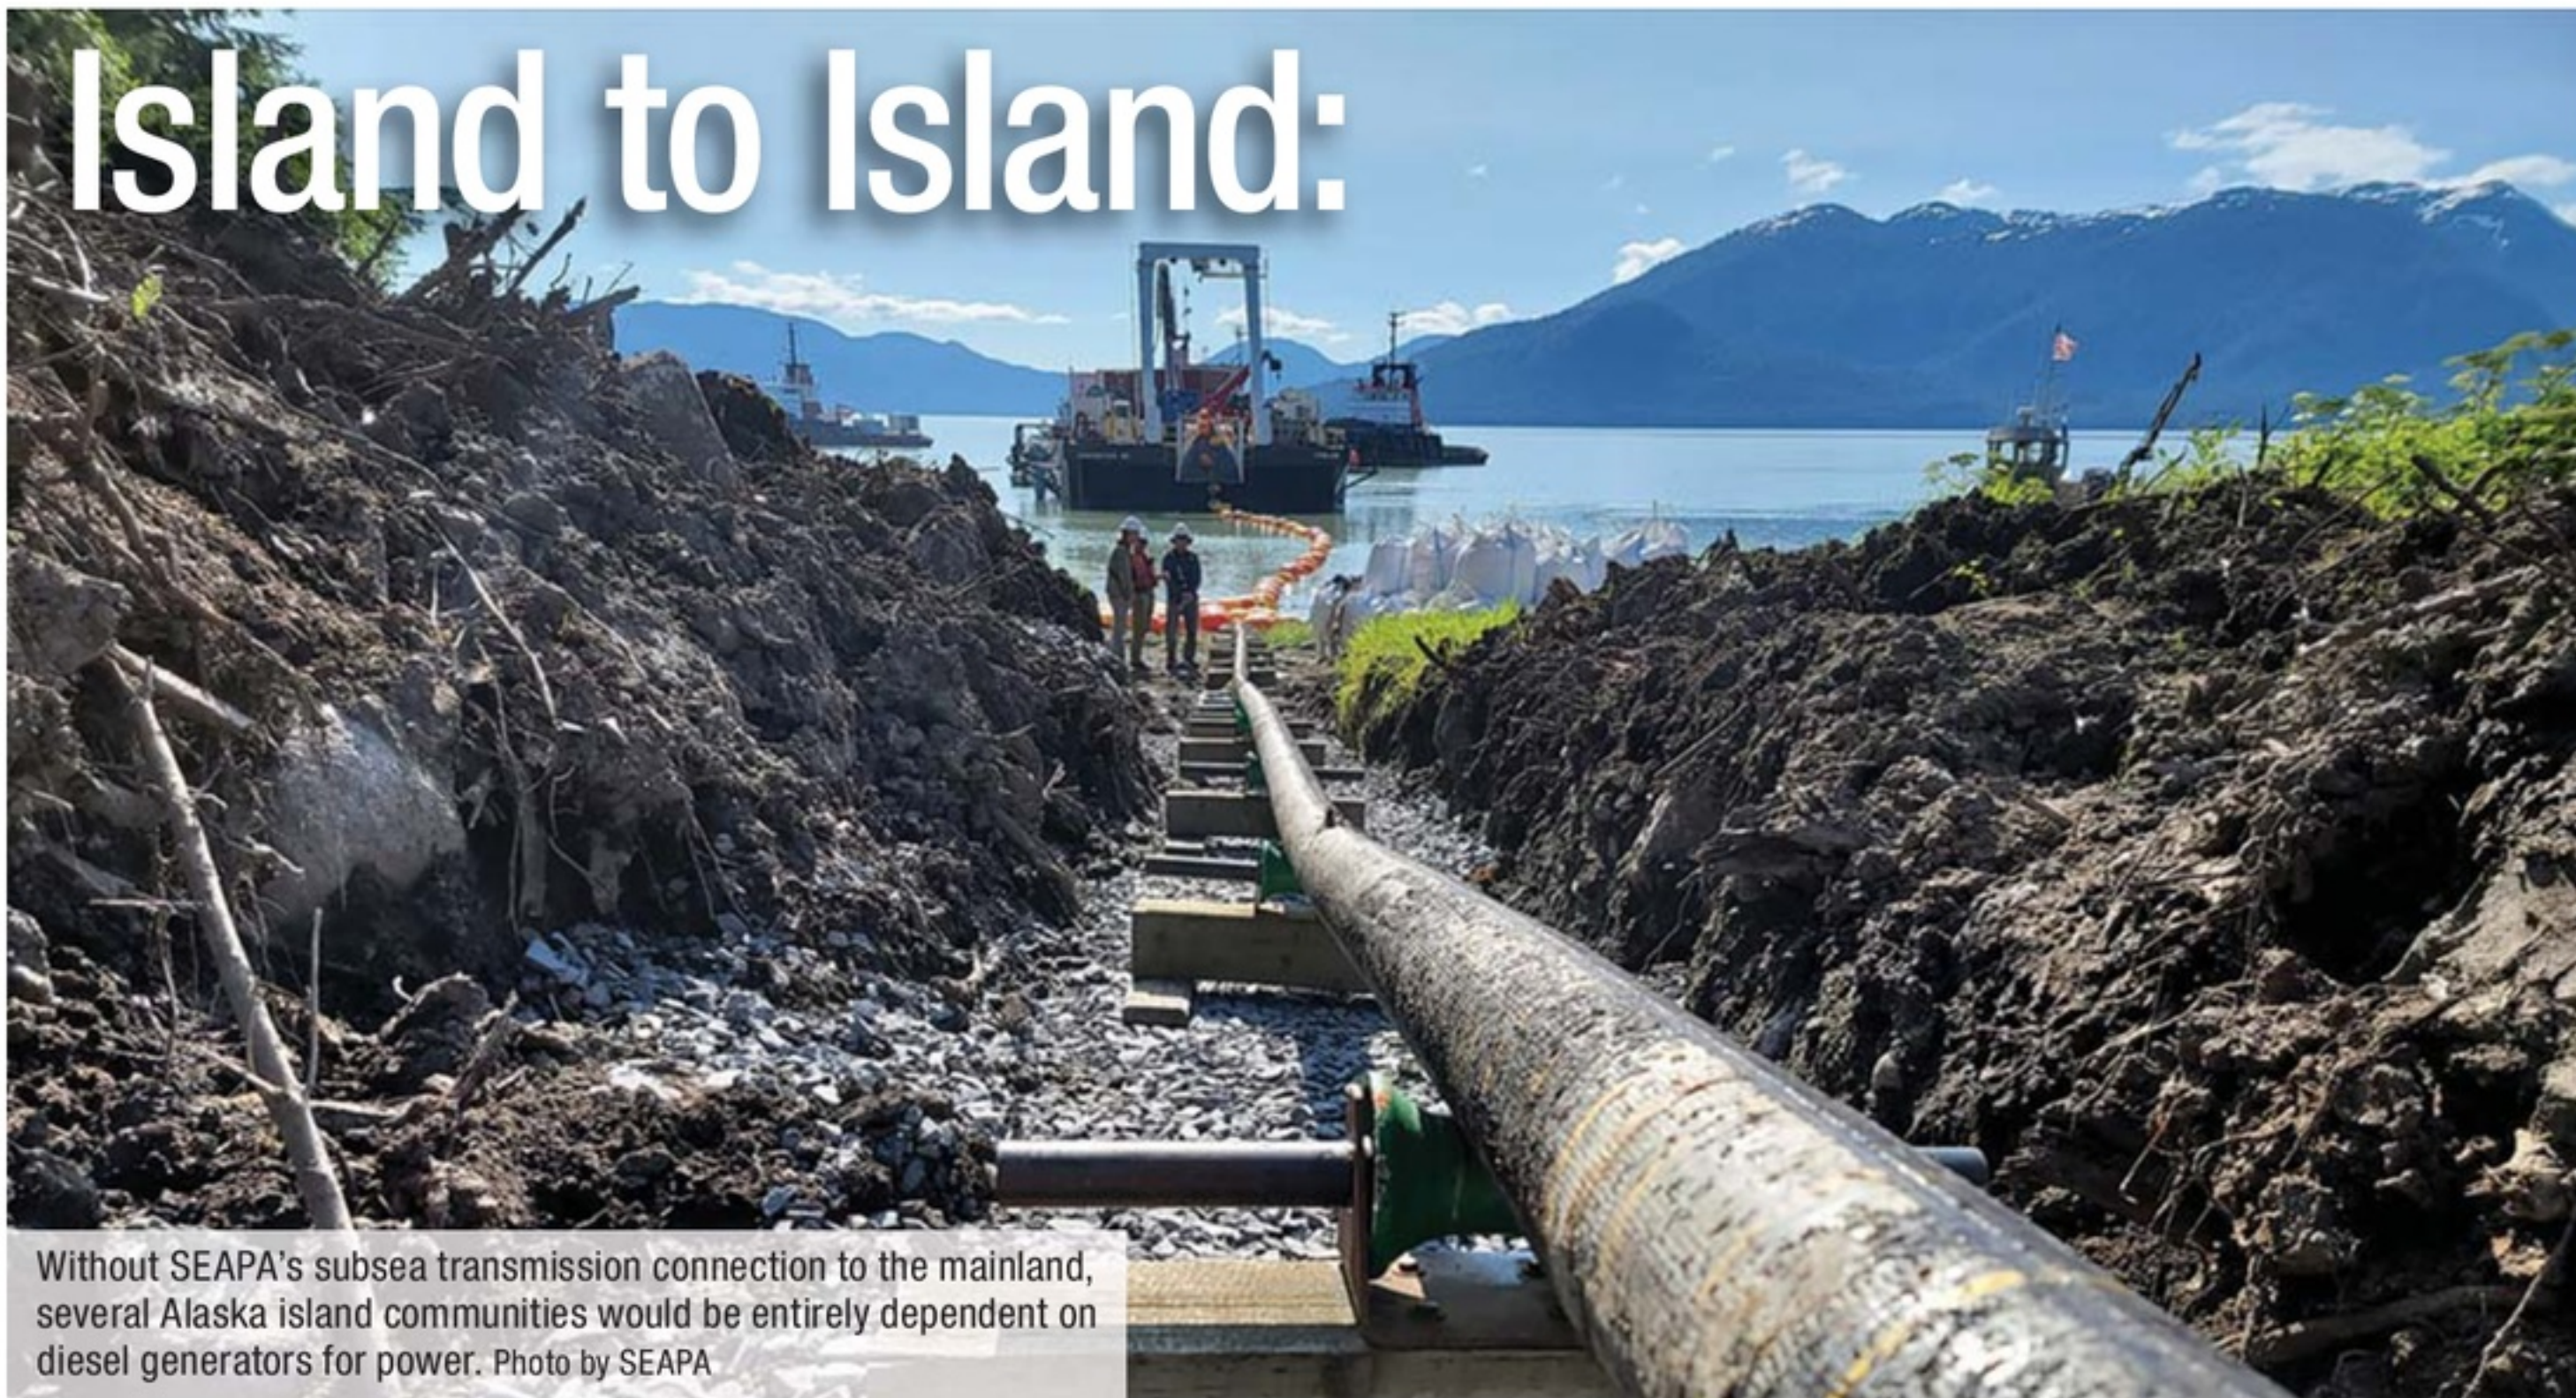
Without SEAPA's subsea transmission connection to the mainland, several Alaska island communities would be entirely dependent on diesel generators for power. Photo by SEAPA

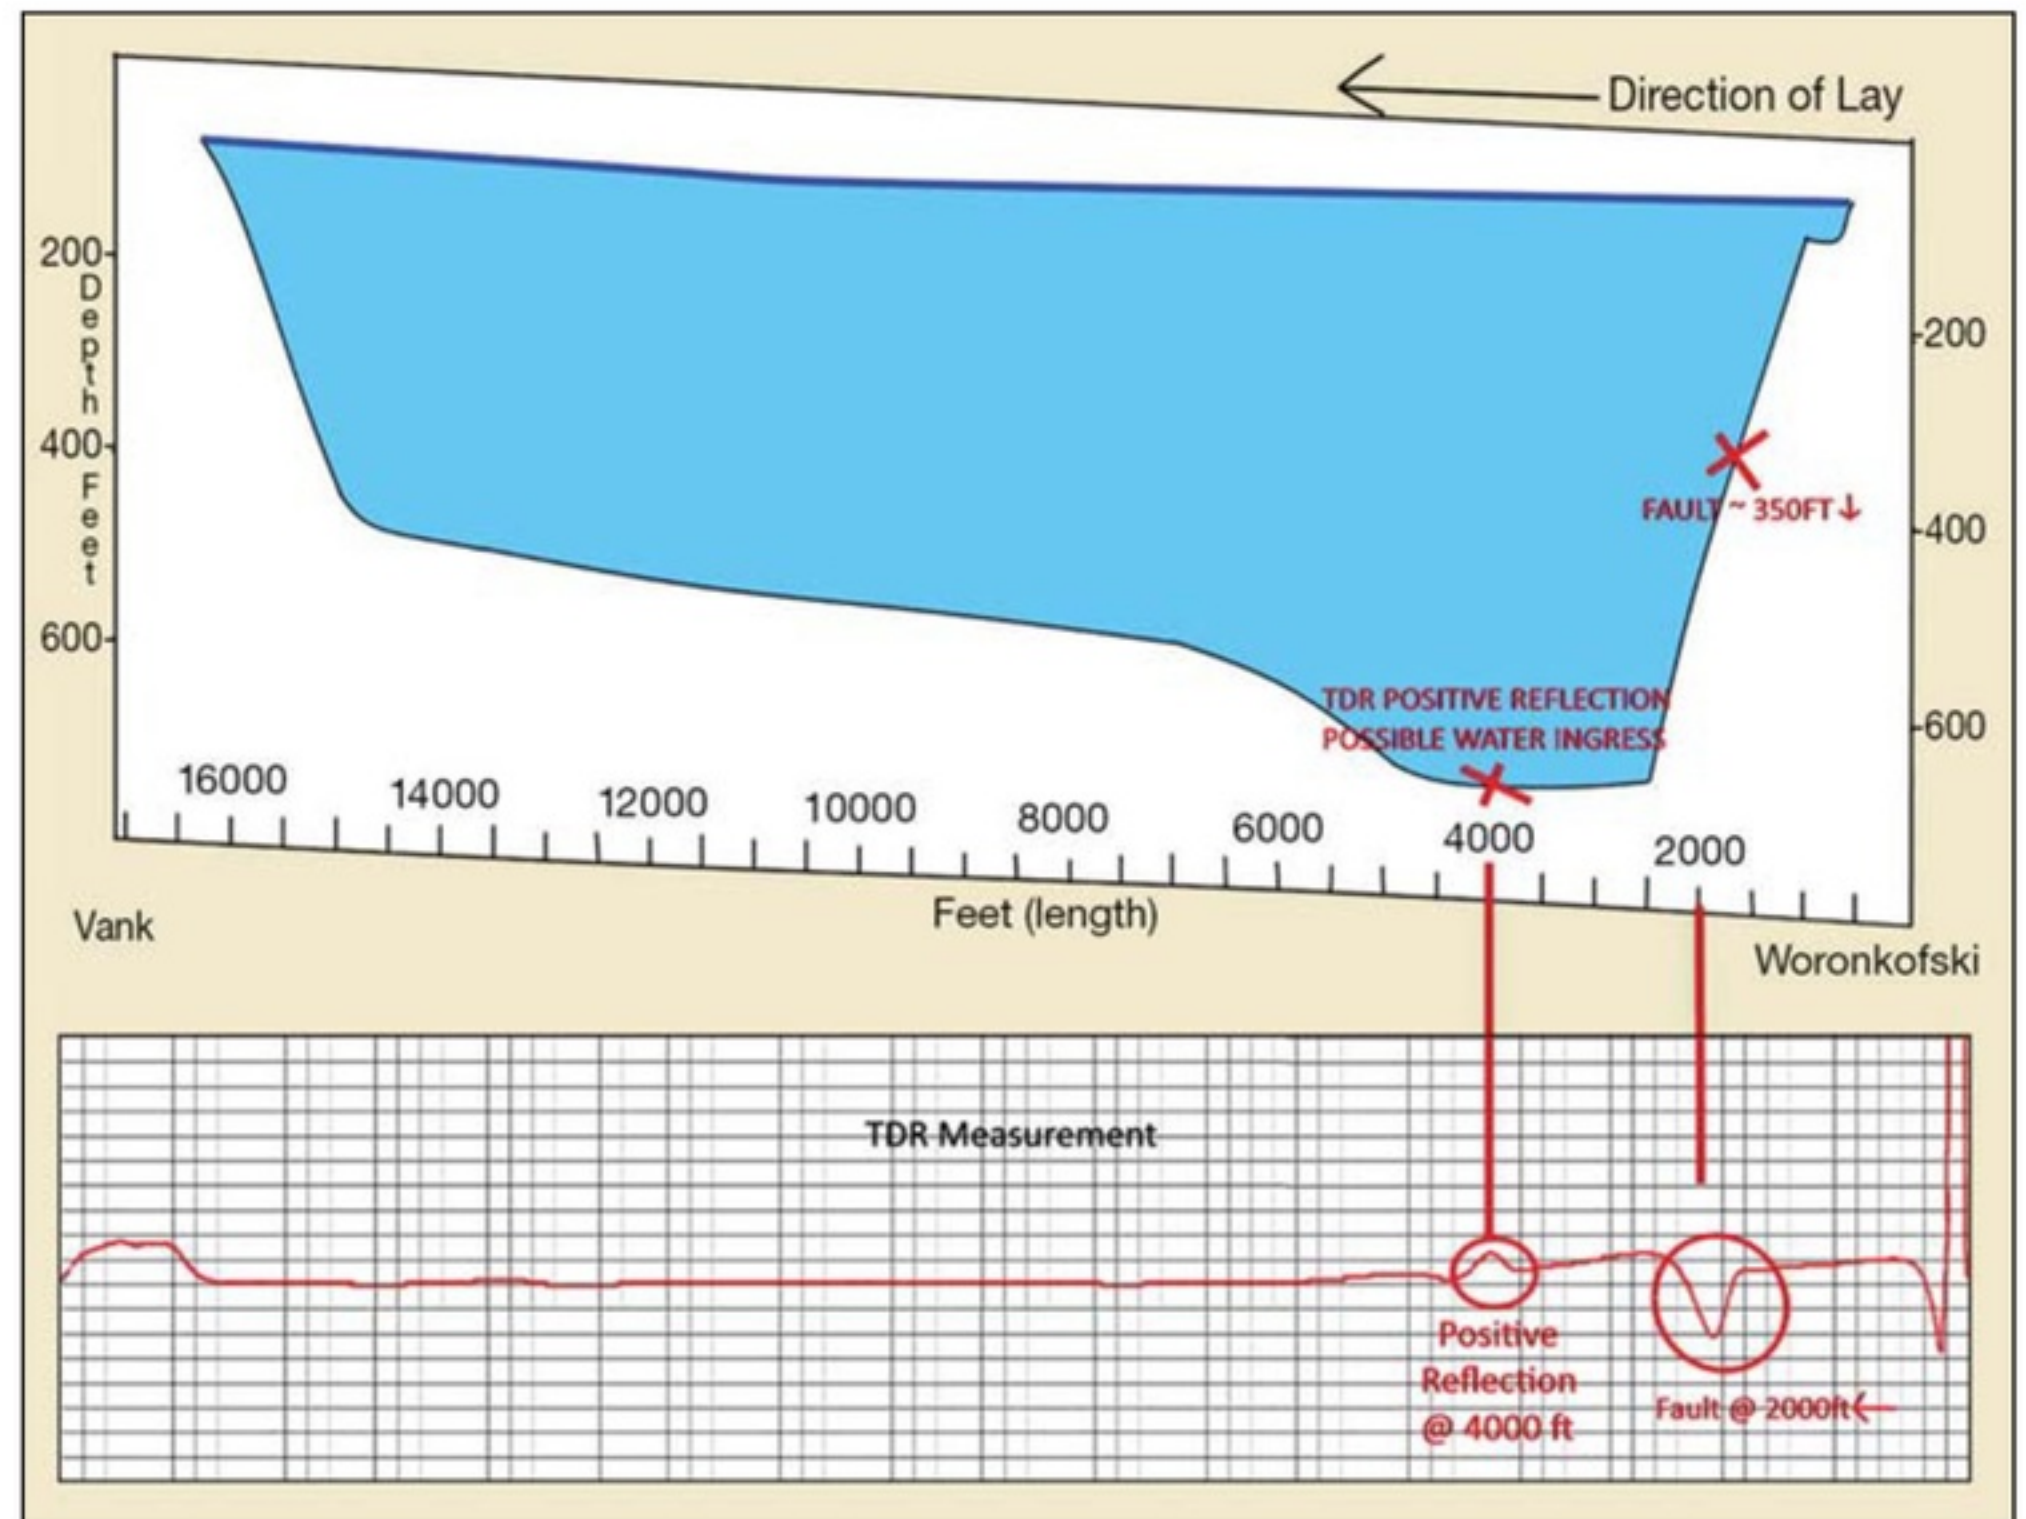
Cable 1 with TDR. Graphic by SEAPA.

Before considering cable replacement, SEAPA investigated the possibility of performing a splice to effectively repair the failed cable. Time-domain reflectometer (TDR) tests were performed

to identify the position of the fault. Test results signaled a negative reflection, indicating a break in the cable at nearly 2000 ft (610 m) offshore at a depth of 350 ft (107 m). A smaller positive reflection also was evident, which was either a possible ghost reflection or water ingress from gravity and density differentials between the seawater and oil.

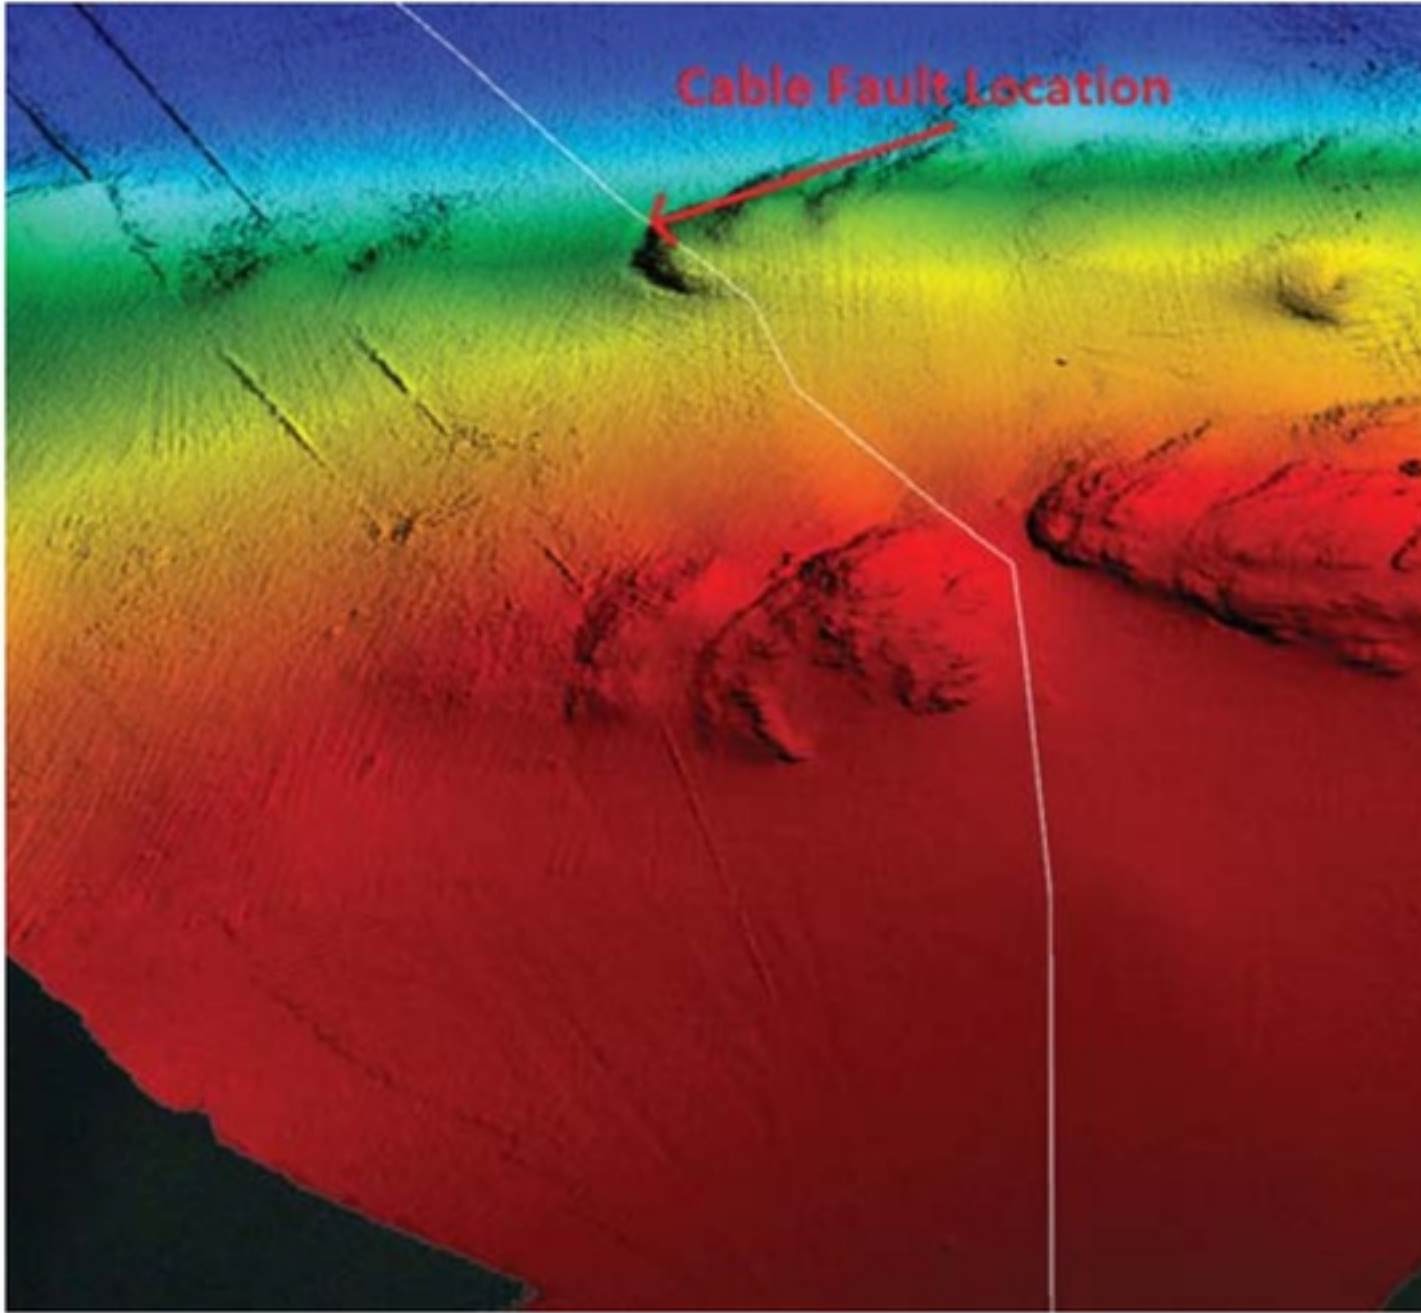
High-Resolution multi-beam sonar bathymetric map. Photo by eTrac Inc.

- ROV footage.
- High-resolution multi-beam sonar bathymetric maps.
- Magnetometer sub-bottom profiles.
- Directional peak cable location surveys.

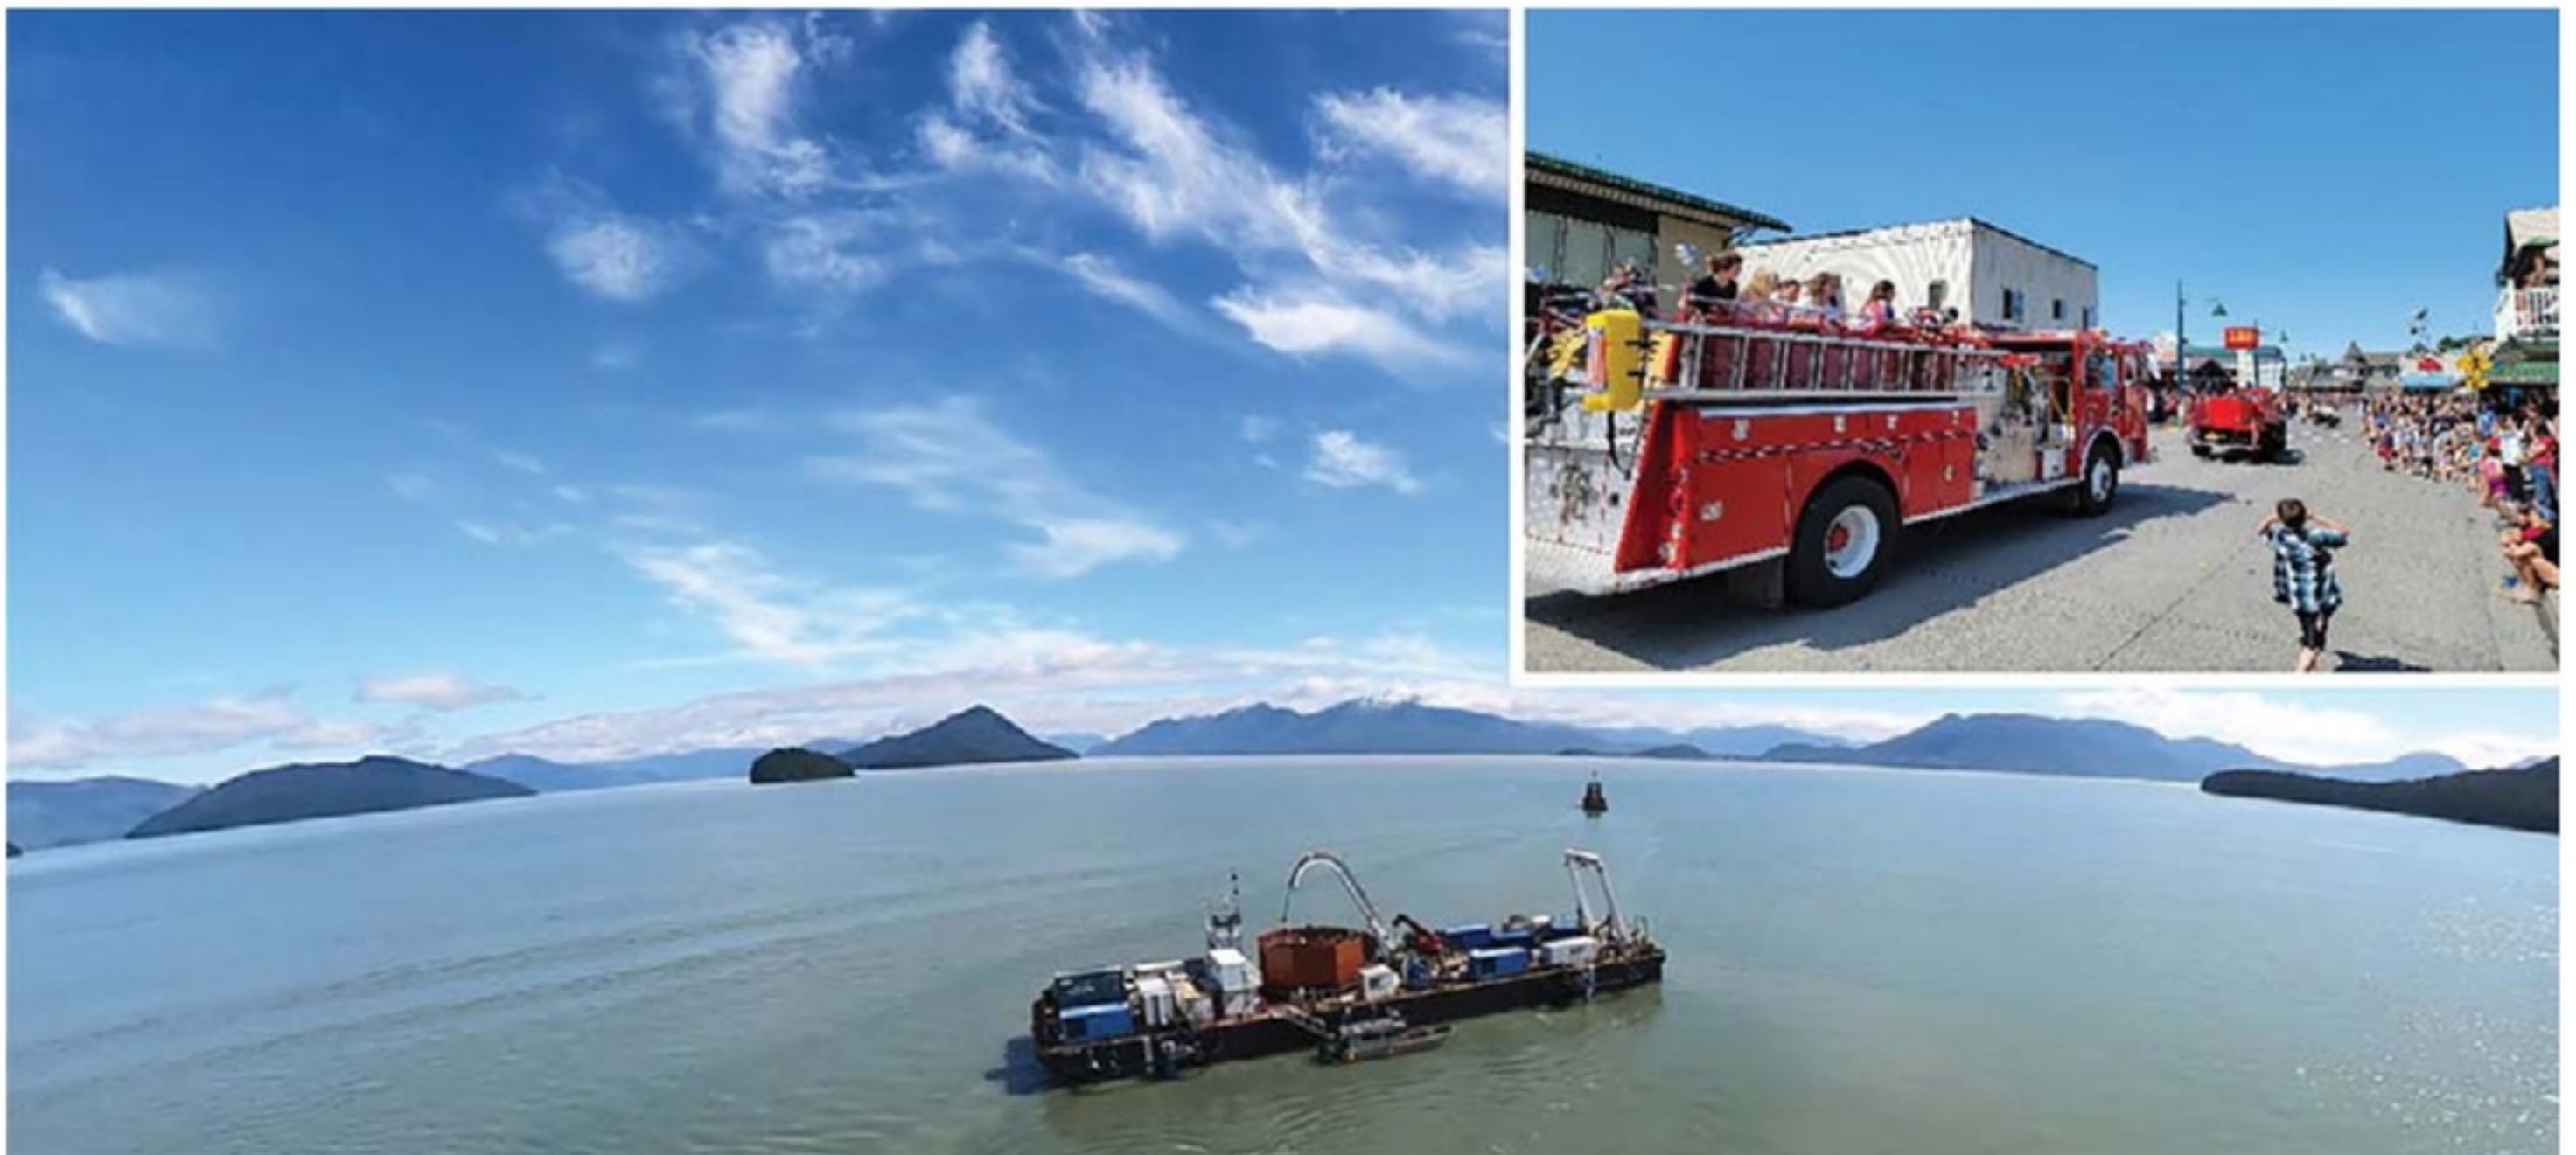
Aerial Footage of Wrangell Alaska during Installation Phase. Photo by SEAPA

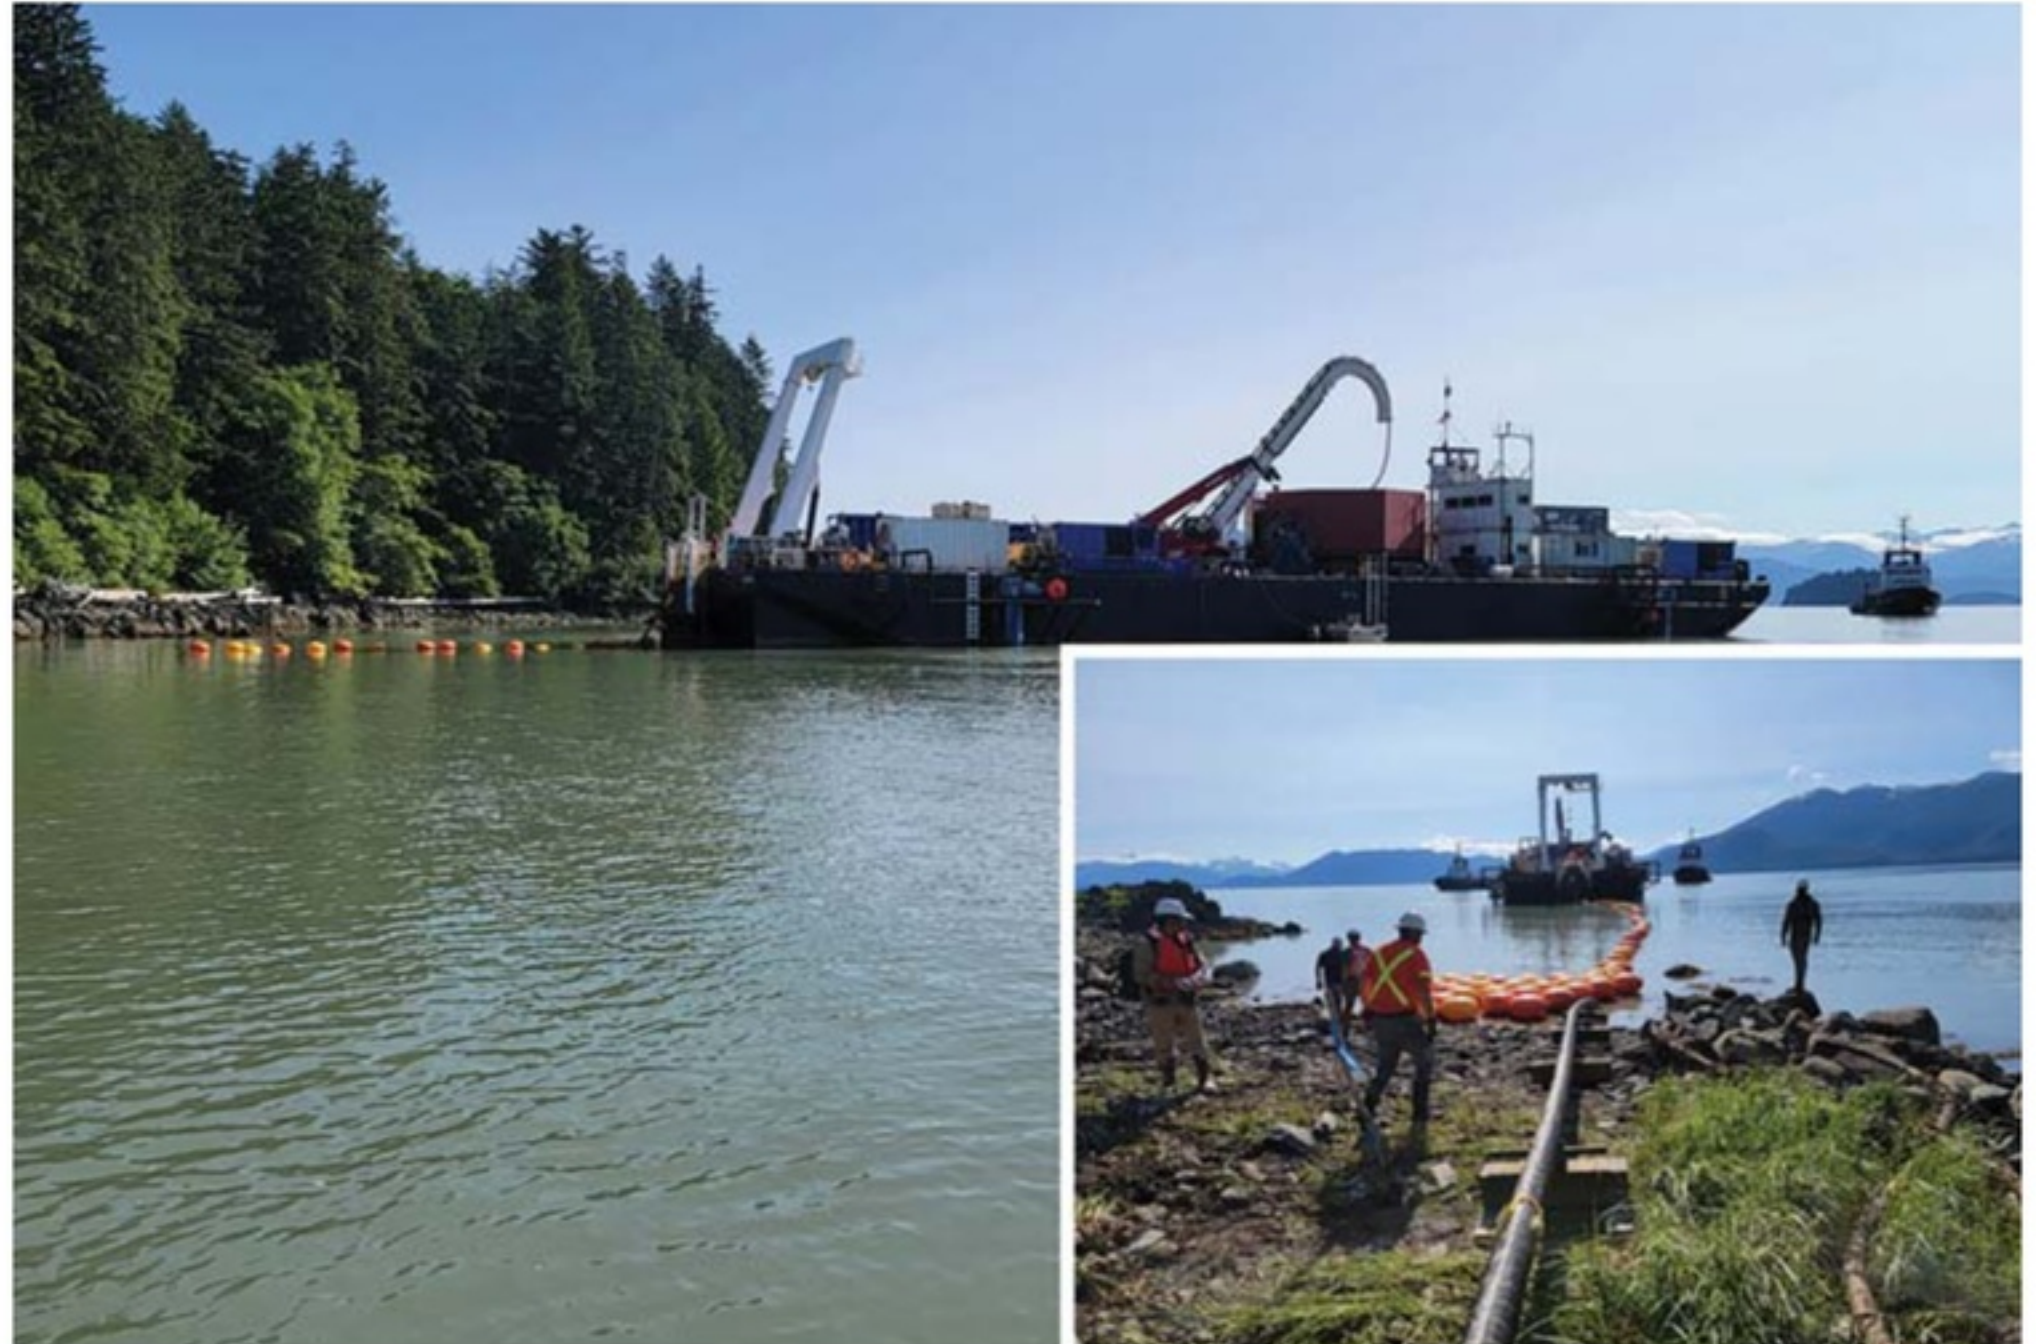
Installation of the 69 kV XLPE insulated cable, Vank Island, Alaska. Photos by SEAPA.

Precise routing plans with precision routing equipment was required for this phase of the project to be successful. Although it was preferred the cable be laid completely on the subsea floor, cable spans were allowed but had to be less than 20 ft in length, with the cable laid entirely within the existing permitted right-of-way. Rock outcrops, boulder fields, cliffs and steep slopes had to be avoided as well as sharp changes in the seabed profile.

Installation was planned to happen during the lowest tidal exchange in the month of July to minimize the effects of tidal currents while the cable was being laid at a depth of 700 ft (213 m) below the water surface. Coincidentally, this window of opportunity occurred on July 4, 2021. While the residents of Wrangell were enjoying Independence Day festivities, SEAPA, Sumitomo and subcontractors were diligently performing operations to successfully install the new submarine cable during the small window of low tidal exchange. The results of this installation phase were exactly as engineers planned.

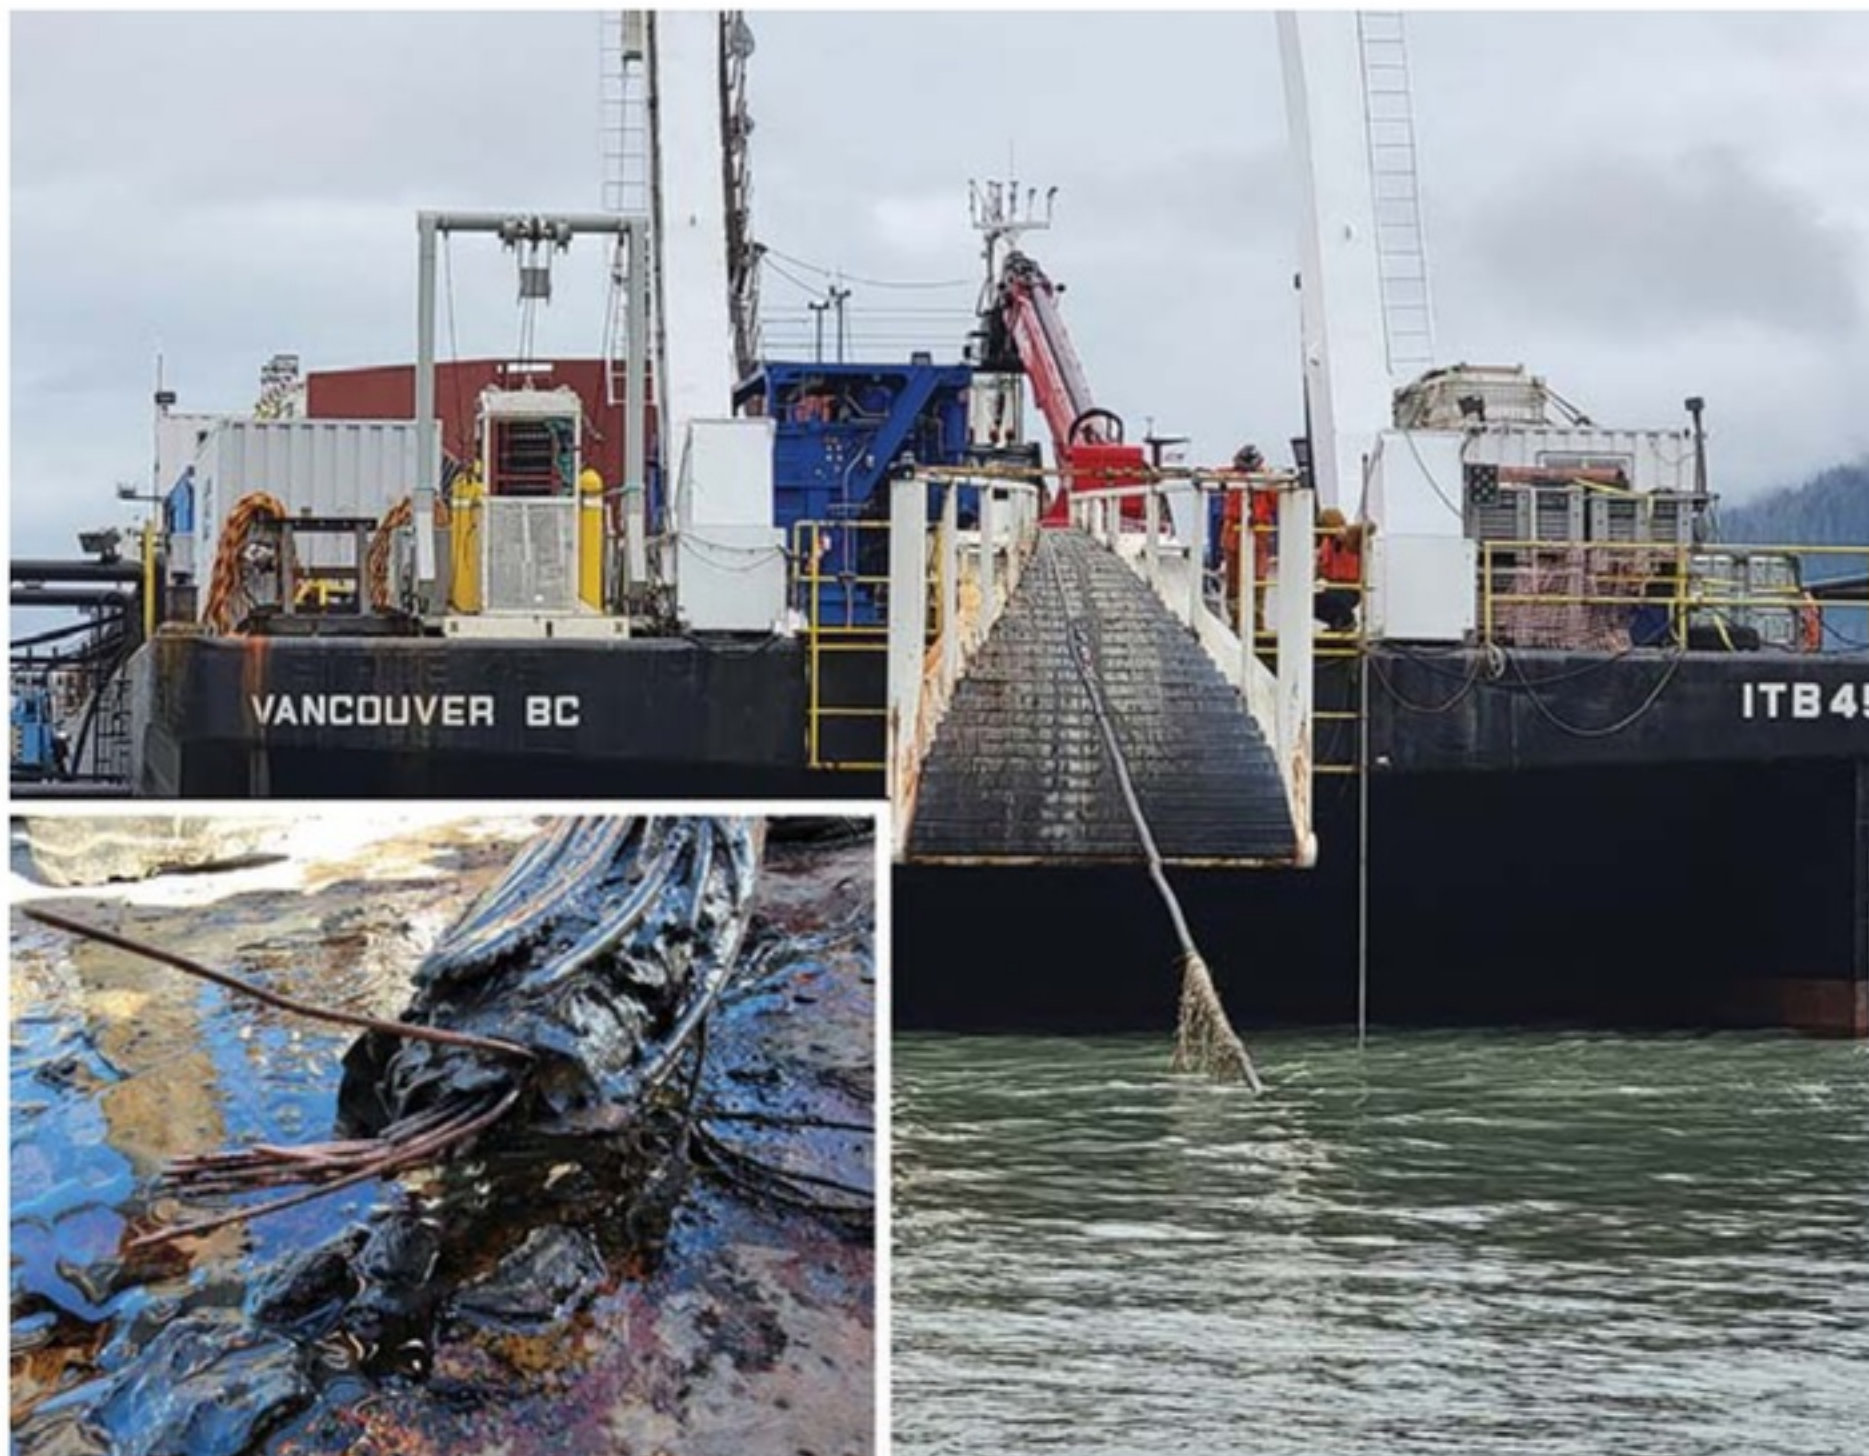
Removal of the oil-filled submarine cable near Wrangell, Alaska. Photo by SEAPA. without incident. An underwater ROV was deployed during operations to confirm the approved cable route and specifications were met. The result was the 3.3-mile (5.3-km) subsea cable was installed with only two short sections suspended less than 6 inches (152 mm) above the seabed and spanning less than 15 ft.

During the oil extraction process, and governed by fluid dynamics, oil extracted on the shoreline was replaced by saltwater at the fault location 350 ft (107 m) below the ocean surface. With 140 gal (530 liter) extracted, nearly 8000 ft (2438 m) of cable was oil free. The cables were capped and hydraulically locked, ready for removal.

- Pulling the shoreline ends onto the vessel, the ITB 45, using ropes and mesh pull grips.
- Using dynamic positioning, the existing cable was extracted onto the ITB 45 and loaded into the cable storage system, specifically designed to contain the cable should an oil leak occur.
- Monitoring tensions so as not to exceed the cable manufacturer's tension limits.
- Calculating fluid dynamics to determine the depth required to maintain equilibrium pressures for CanPac Marine Services Inc. divers to install caps without oil escapement.
- Deploying divers at the faulted cable ends to cap the cable underwater and prevent oil escapement.
