TRANSMITTAL MEMORANDUM

RE: **Contract No. 16-16 – Planning and Design of Port Improvements, Moffatt & Nichol**

CONDITION ASSESSMENT REPORT

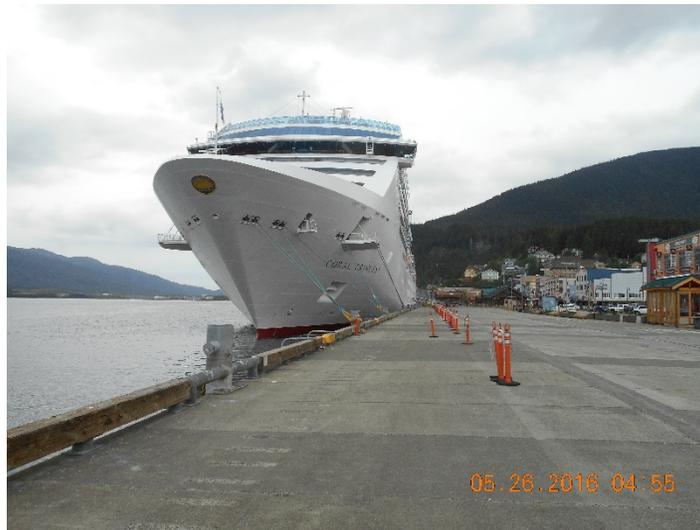
Exposure to the elements and ordinary service occupancy has caused normal wear and tear to the surface of the precast pre-stressed concrete panels, though no significant defects were observed. Regular cleaning and maintenance likely contribute to the overall satisfactory condition of the deck. A chain drag inspection identified several locations at grouted joints between panels with apparent voids in the grout. These areas have been identified on a plan drawing included in Appendix B

Figure 30: Typical Deck Surface

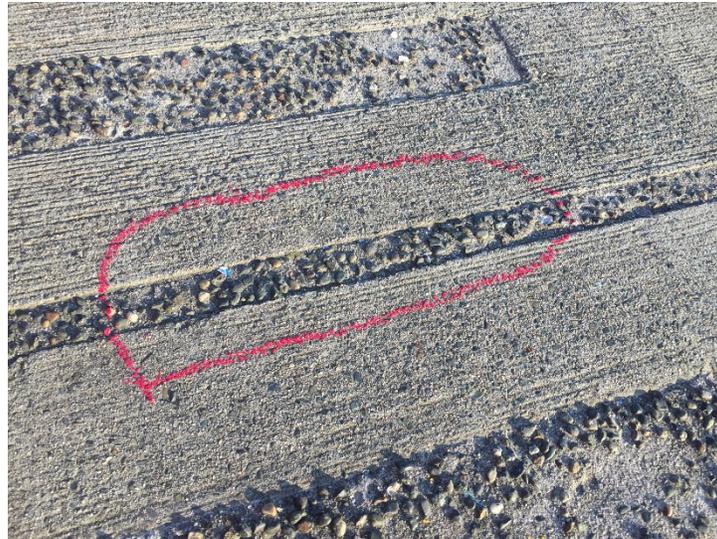
Figure 31: Apparent Grout Voids

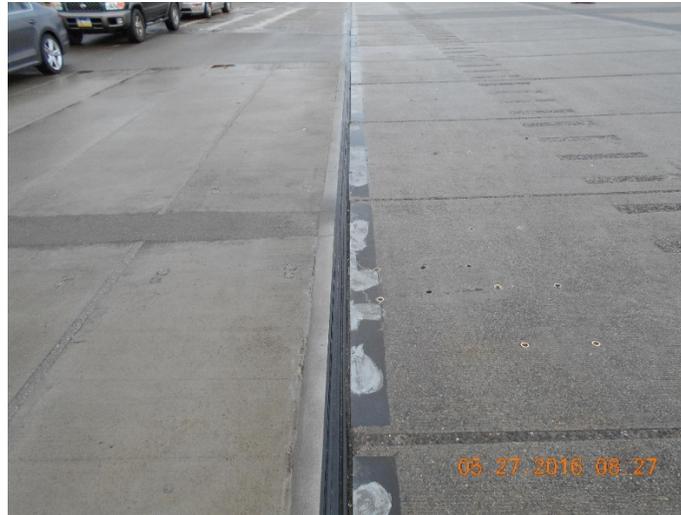
The entire length of the Berth 1 and 2 expansion joint was inspected. No significant defects or damage was noted, beyond normal debris accumulation.

Figure 33: Expansion Joint

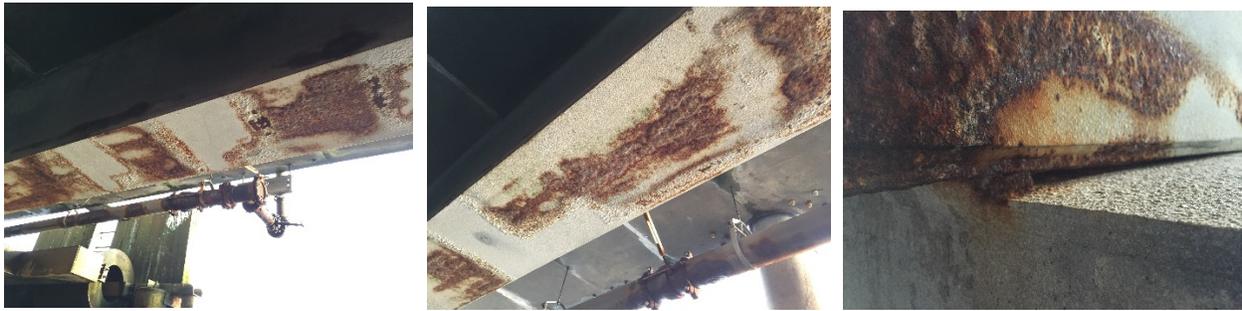
The dock's box girder substructure framing appears on the whole to be in generally serviceable repair. Corrosion appears to be the only significant impact to the remaining life of the substructure. The box girders were originally spray metalized prior to their installation in 1994. It is believed that the box girders were blasted and re-metalized circa 2005 as part of a corrosion mitigation project. The box girders are again showing signs of corrosion. The corrosion is primarily located on the bottom face of the beams and more prominent on the seaward girders. It is not apparent whether the corrosion has occurred as a direct result of coating failure or if the material is corroding beneath the coating, causing the coating to fail. It is also possible that the water-tightness of the box has been compromised at locations which have allowed rainwater to infiltrate; causing the corrosion to initiate from within the section.

Additionally, it was noted during a rain event; which occurred during the underside inspection, that runoff at the seaward edge of the dock tends to travel back along the top flange of the double-H pile cap. Corrosion also appears to occur more frequently at locations where the box girder welds to the pile caps. It is possible that water tends to pond at these locations, causing more corrosion on the girders themselves and at the welded connection.

Figure 34: Box Girder Corrosion

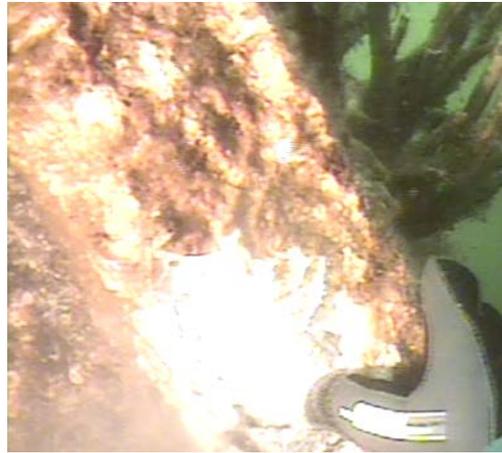
The cathodic protection system is believed to have been installed around 2005. The system consists of sacrificial aluminum anodes welded directly to the steel pipe piling. During the underwater inspection, anodes were visually and tactilely inspected when encountered. Of the anodes inspected, most were observed to have between 25% and 50% of their sections remaining. The anodes will continue to be consumed as they protect the structure. It is estimated that the anodes inspected have between 5 and 10 years of useful life remaining, assuming they are consumed at a similar rate. After the anodes are consumed, the galvanized coating will be consumed at a more advanced rate and eventually the piling will begin to experience section loss and reduced structural capacity due to corrosion. The condition of encountered and inspected anodes during the underwater inspection is included in Appendix C.

Figure 36: Typical Anode

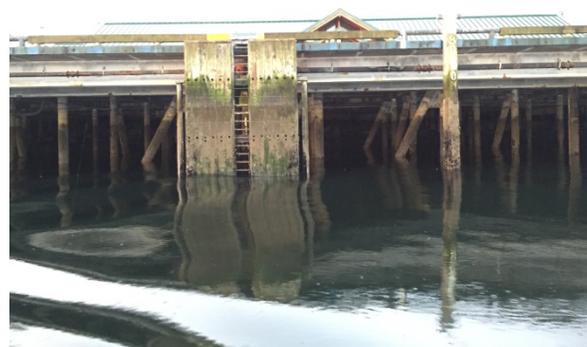
During the inspection, it was noted that at several of the floating fenders the restraint chain became bound upon their guide pipes on one or both ends, causing them to become fully or partially submerged or suspended based on the elevation of the tide. Fenders inadvertently bound up in such position could cause or worsen damage to the structure during a hard or abnormal berthing event. If a vessel hull were to fail to make contact with the fender, it might impact the fender panel structure beyond, resulting in dangerously high levels of energy transfer.

Figure 37: Fender Panel with Bound Fender (submerged)

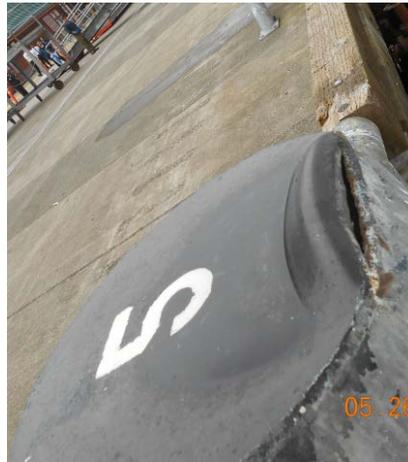
The mooring bollards are generally in good condition. They are showing moderate coating loss due to abrasion from line handling and minor to moderate corrosion is visible at those locations. On several bollards, on the northern end of the dock, the outside face of the bollard at the cap plate are deformed from an apparent impact.

Figure 39: Damaged Bollard Cap

The mooring bollards were not inspected below the waterline, except when encountered incidentally; no damage was noted below the water line. These galvanized piling do not appear to be protected by sacrificial anodes. Anticipating their remaining service life is difficult in the absence of additional data; but the addition of passive cathodic protection is recommended.

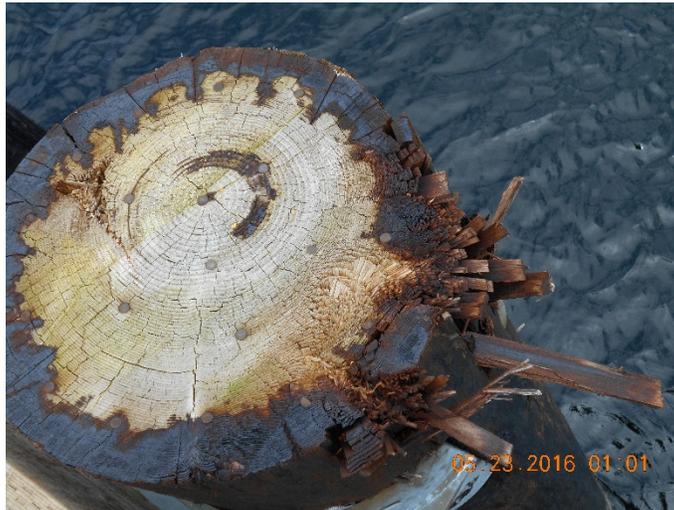
The original fender piling on the shoreside of the dock were recently replaced with new timber piling. The timber fender piling are generally in good condition with few signs of deterioration or decay. Only minor damage was noted on top of the piling. The damage is mostly superficial and does not warrant repair or replacement of the timber piling. The top of the fender piling is un-treated and may accomodate decay, despite the copper nails intended to prevent rot and decay.

Figure 42: Fender Pile Top With Minor Damage

The minor damage to the fender piling does not necessitate repair. The pile tops do not appear to be treated. Copper nails were installed in the pile tops to prevent rot and decay, however, with their effectiveness is very likely limited to the top few inches of the pile. It is recommended that the pile tops

be capped with a bituminous roofing tar or a coal tar epoxy to prevent rot of the pile tops. Also, all missing connection hardware should be replaced, to ensure that pile tops are laterally supported, according to their original design.

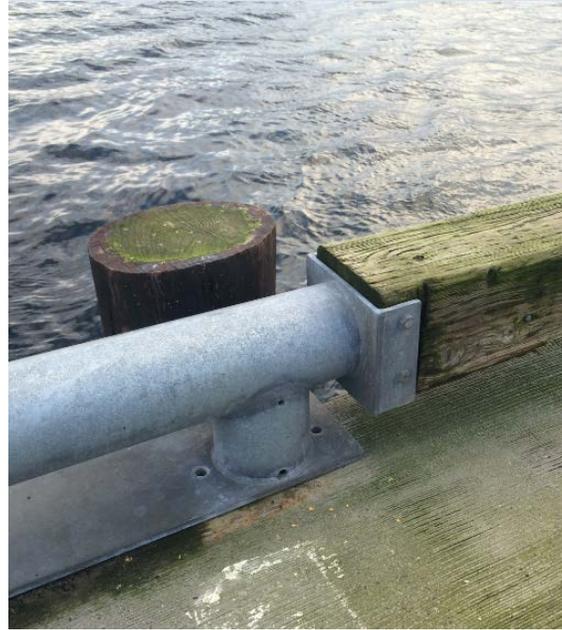
At the extreme south end of Berth 1 and 2, there are missing bolts at the bullrail base plate at some of the timber fender piles. As the fender guides share these bolts with the bullrail, their absence results in the top of the fender pile being laterally unsupported.

Figure 43: Missing Fender Pile Bolts

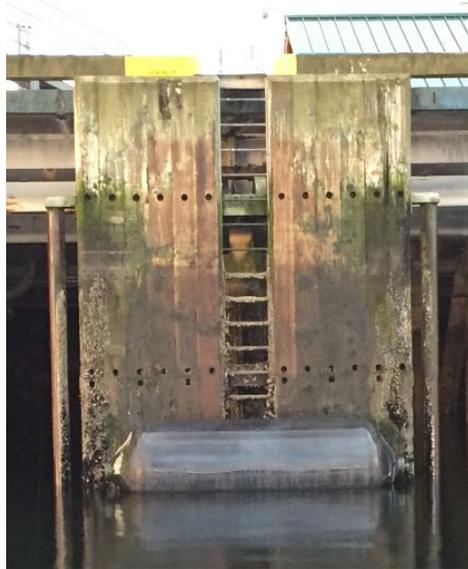
Ladders on the seaward face of the dock are also inaccessible from the water, due to the location of the floating fenders. The absence of fully usable ladders and the potential for relatively high currents, particularly at the south end of the dock, should be considered a major safety concern.

Figure 45: Safety Ladder Blocked by Fender

The Tongass Narrows are known to be experience moderate currents during tide changes, which would challenge even a strong swimmer. The safety ladders should be extended to a depth below the lowest occurring extreme tide or replaced with longer ladder assemblies. It is also recommended that additional safety ladders be installed on the face of the dock away from the fender panels, as the ladders at those locations are inaccessible due to the presence of the foam-filled floating fender.

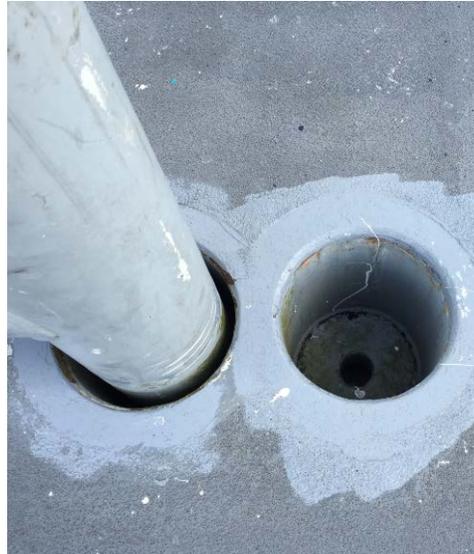
The removable guardrail sections were found to be in good condition with only minor coating damage and minor localized corrosion. It was noted that some sections of guardrail are stockpiled on the float and appeared undamaged. The empty guardrail pockets were found to have coating damage and light corrosion. Some light marine debris was found in the pockets.

Figure 48: Guard Rail Pockets

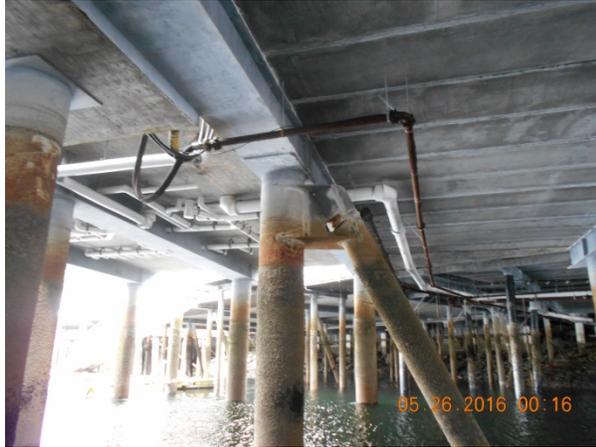
The Berth 3 Platform and the Dock Street addition were inspected from the topside and by skiff. As these are of relatively new structure, these structures are in relatively good condition. The support piling has experienced minor coating loss and corrosion in the tidal zone. Approximately 40-50% of the galvanized coating appears to have failed in this area. Eventual remediation will be required, but by and large, the piling are not in immediate danger of significant section loss. The piling were not inspected below the waterline, however, they are not presumed to be protected by a cathodic protection system. The below waterline condition could be expected to be similar to the condition of the Berth 3 dolphin piling.

Figure 50: Pile and substructure corrosion

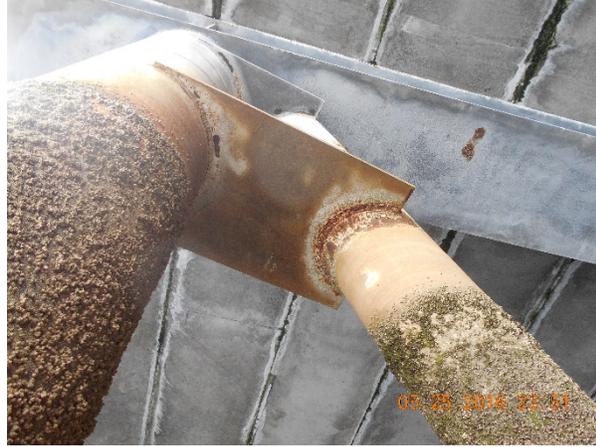
The welds at the connection between the batter piles and plumb piles are showing signs of moderate corrosion and there is some scaling near the weld. This area should receive relatively prompt attention. The steel substructure was found to be in good condition, with no structural defects noted, and the coating was found to be over 90% intact with only minor localized corrosion.

Figure 51: Corrosion at Connection

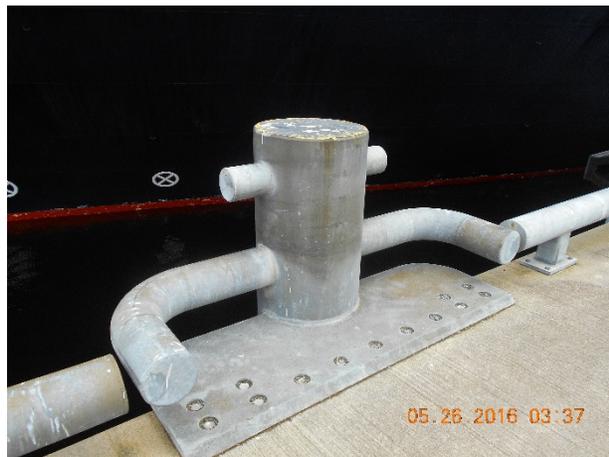
The bollards were found to be in good condition with only minor coating damage and light corrosion from lines rubbing on the bollard and deterioration of the galvanized coating in the tidal zone. As with the support piling, the mooring bollard piling are reportedly not protected by a cathodic protection system and will eventually be subject to the effects of corrosion if not adequately protection is not provided.

Figure 52: Bollard Abrasion and Corrosion

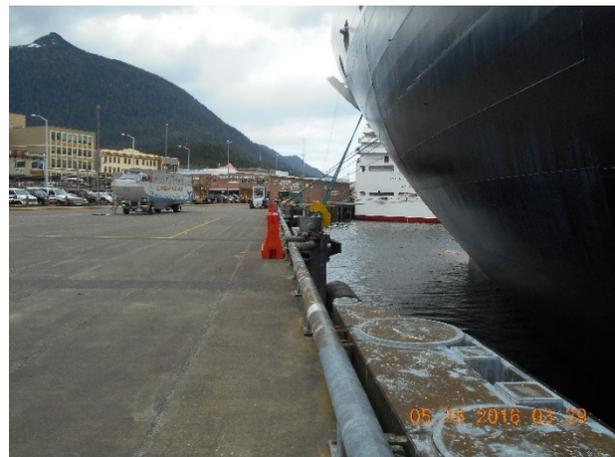
The steel pipe bullrail, which is functionally more of a pedestrian and vehicle guardrail, was found to be in good condition. The bullrail showed no signs of structural defects and the coating appeared to be at least 80% complete with localized minor corrosion.

Figure 53: Bullrail Corrosion

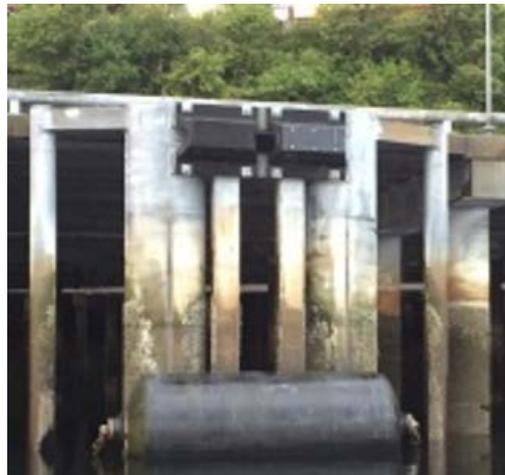
The fender panels at the Berth 3 platform and the Dock Street addition appear to see only very occasional use. As such, they appear to be in good condition with only minor damage. One of the arch fenders on the middle panel at the Berth 3 platform is missing its UHMW-PE face. Otherwise, defects on the fender panels appear to be limited to moderate coating loss and corrosion on the steel fender panel components and fender piling.

Note that the fenders and piling were not inspected as part of the underwater inspection. They are not thought to have any form of cathodic protection, and as such, it may be expected that coating loss and corrosion will continue below the water line; eventually leading to section loss and reduced structural capacity.

Figure 54: Fender Missing UHMW-PE

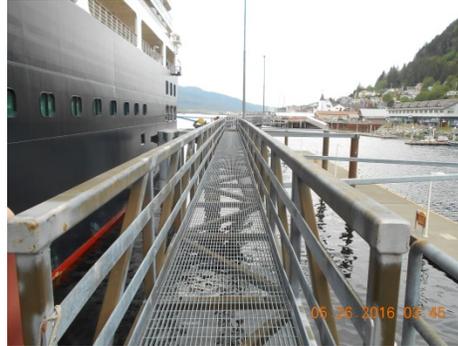
The catwalks were visually inspected from the topside. Each catwalk structure was found to be in good condition with minor coating failure and minor corrosion over approximately 25% of the catwalk surface area. No structural defects were observed on the catwalk framing or grating members. The hinge points on the articulating catwalk were inspected and no excessive wear or damage was noted.

Note that the catwalks were subjected to significant loading due to the above-references allision. One section of catwalk was dislodged entirely from the dolphin cap at one end and fell partially; being restrained only by the lateral bracing attaching it to the tendering float guide pile. At other sections, the restraining bolts were sheared off and the walking surface was damaged. This damage has all since been repaired.

Figure 55: Catwalk Corrosion

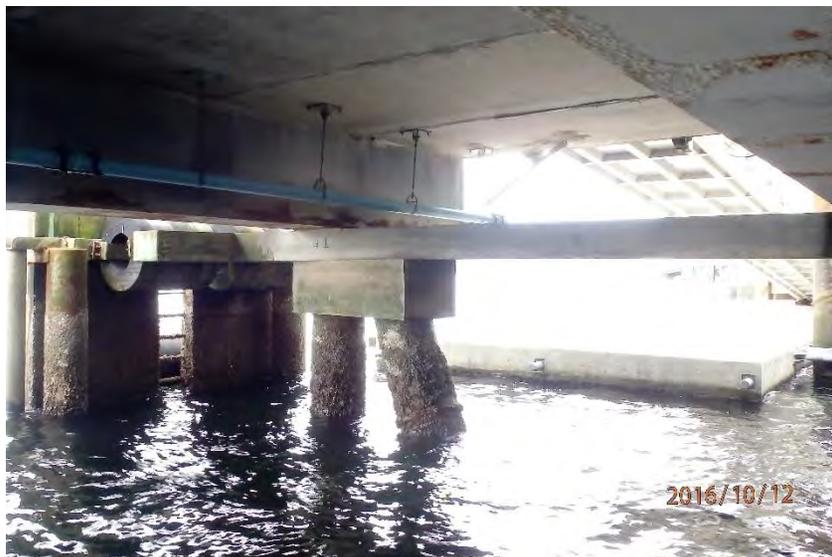
Bent 1 Overview (looking north)

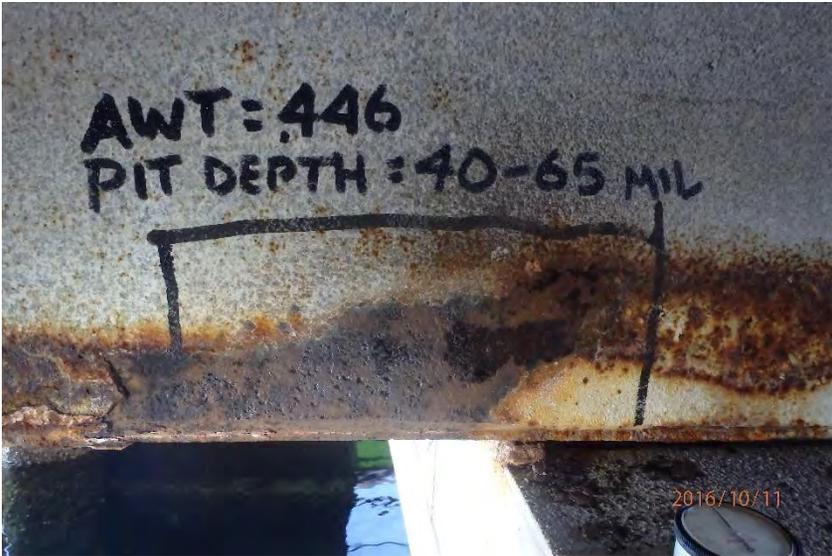
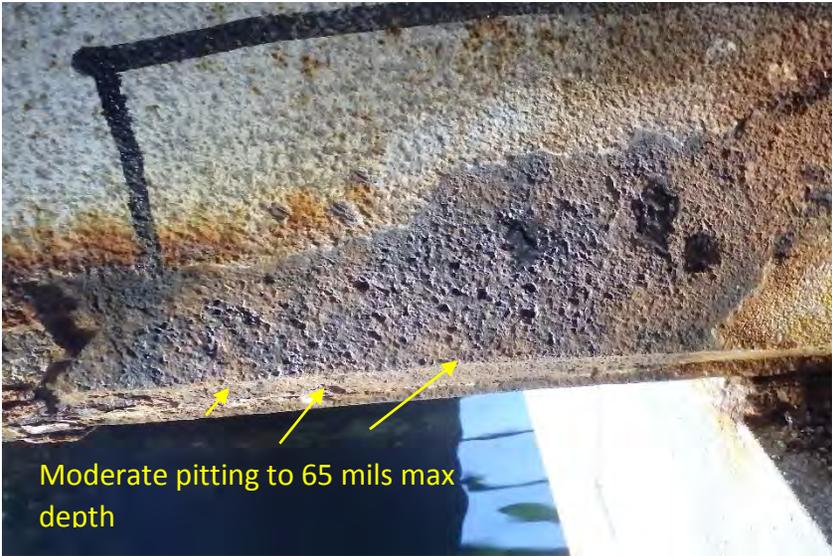
Beam 1, shore side, above S. edge of piling cap (UT Location 3)

Moderate pitting to 65 mils max depth

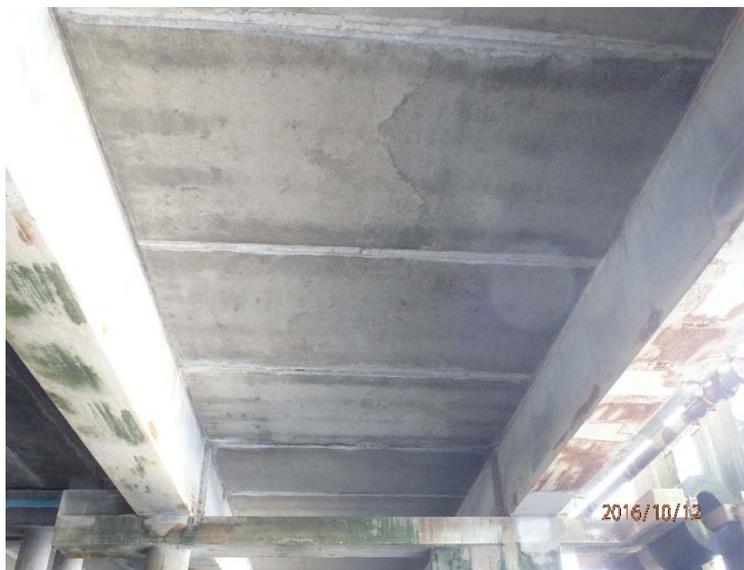
Overview of Beams 1 & 2 between Bents 2 & 3, looking south

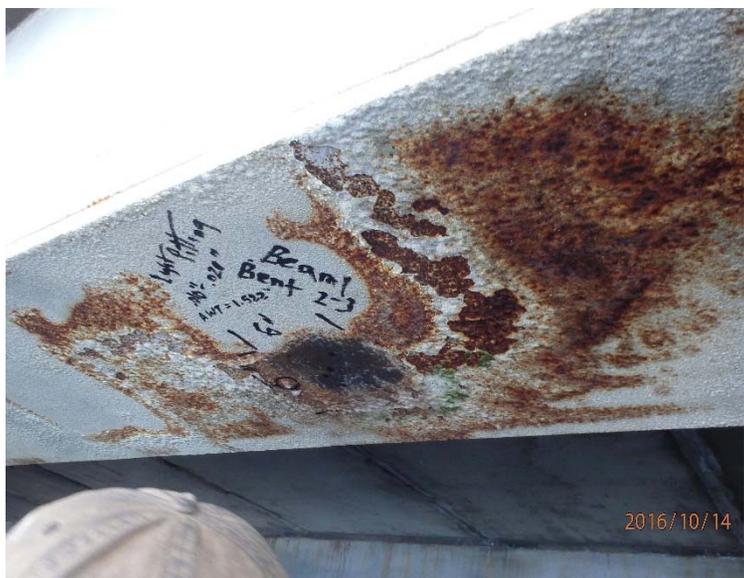
Beam 1 exam area marked with UT and pitting notes

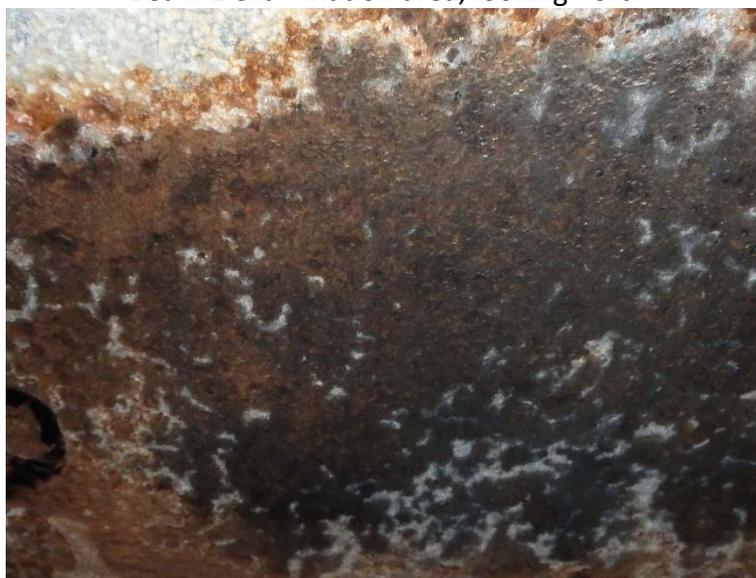
Beam 1 exam area corrosion close-up

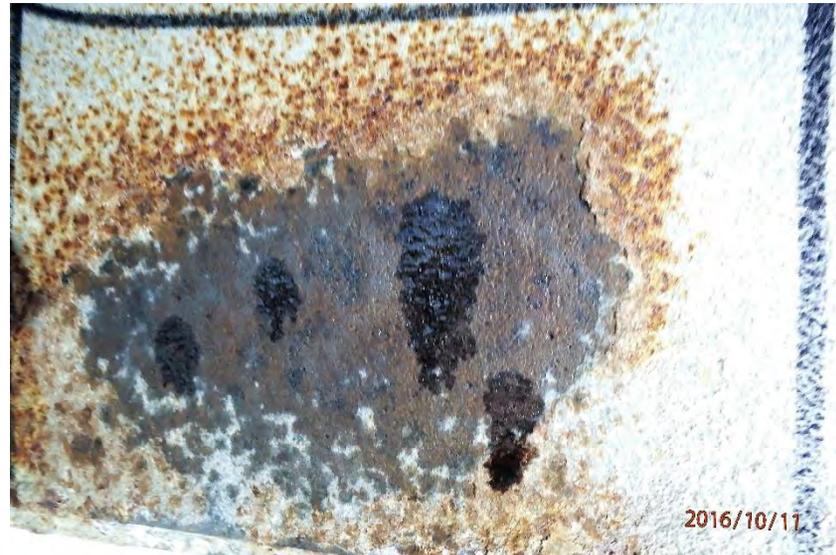
Close-up of UT Location 2

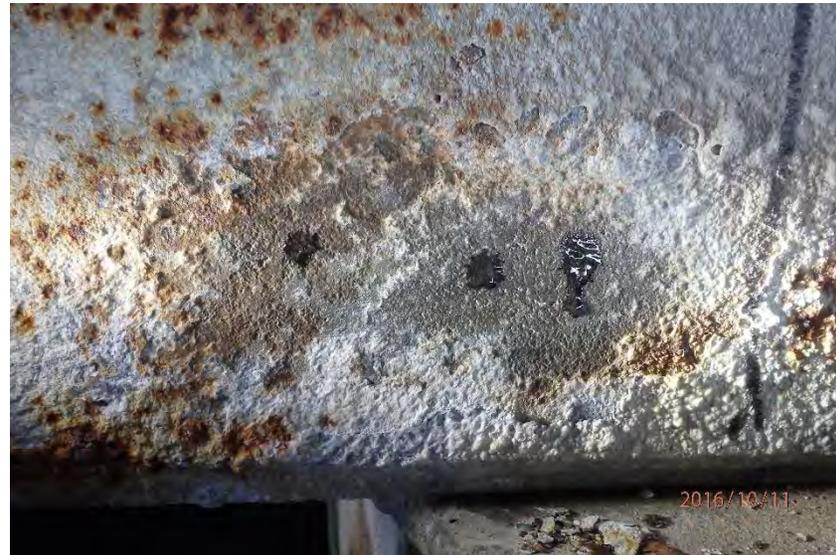
Close-up of UT Location 3

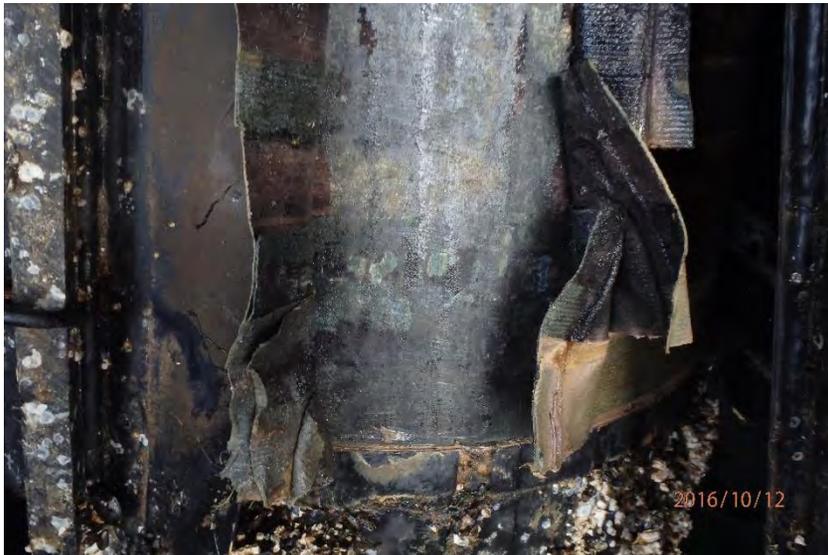
As-found condition of piling steel surface (no visible corrosion)

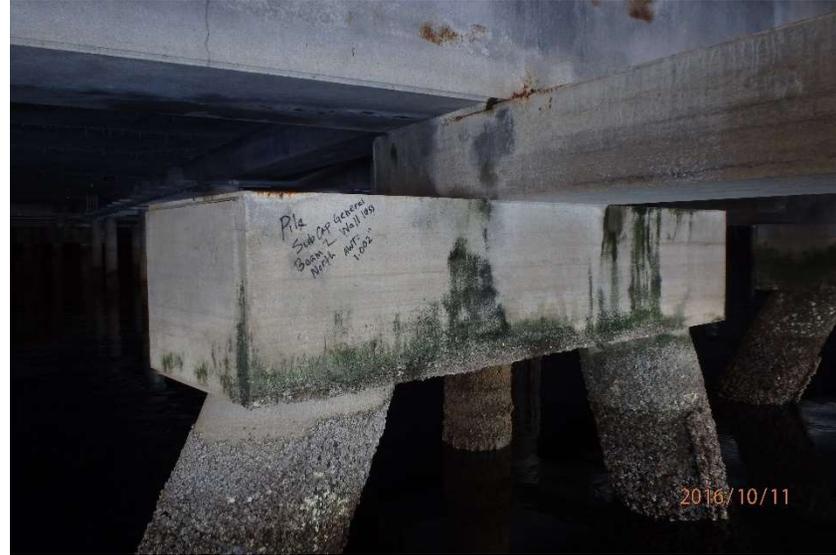
Bent 7 shore side overview (under Beam 2)

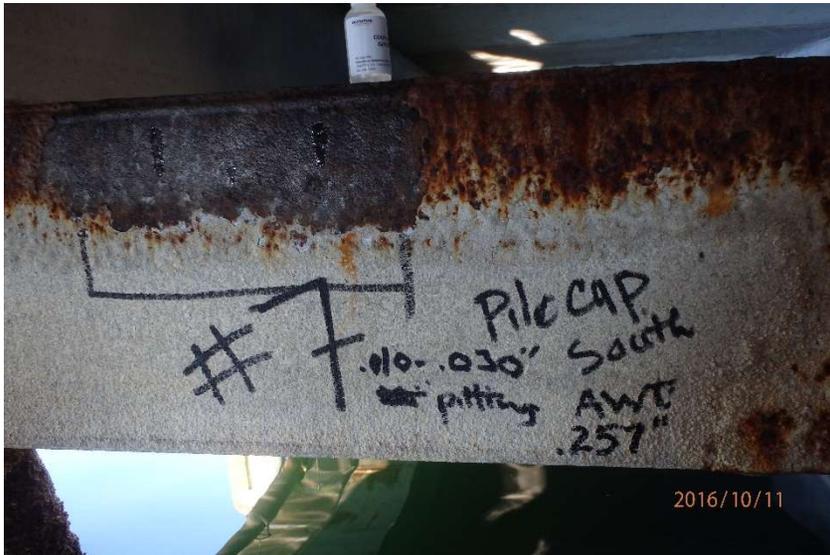
Component	Corrosion Notes	UT Location	Min. Thickness (mils)		Comments:
Piling cap, south side, between Beams 1 and 2	Light pitting is present beneath the area of failed coating. Max pitting depth measured at 30 mils (0.030"). Corrosion visible through failed coating. Coating DFT: 46 to 78 mils	1. In area cleared for examination on south face of piling cap	UT Loc.	AWT	Failed coating at examination location appears to have been previously repaired. Nominal thickness:250 mils Lowest RWT: 227 mils

Piling cap, south side (UT Location 1)

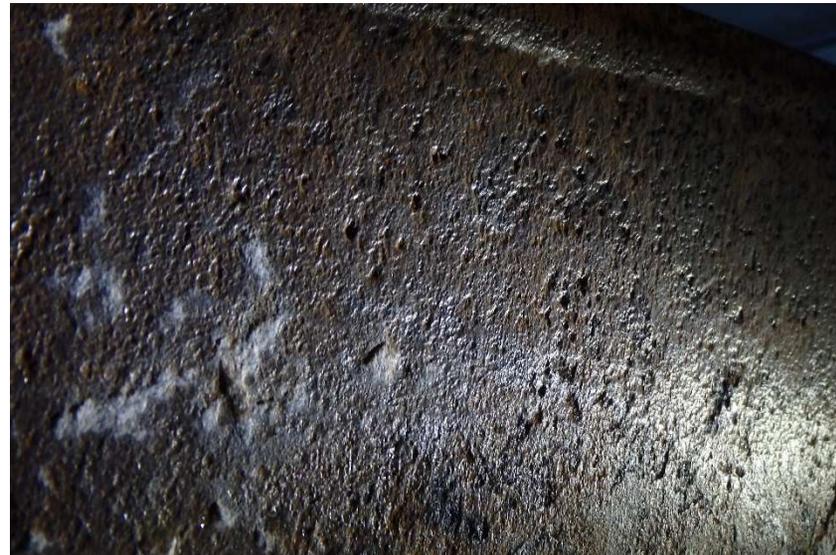
Close-up of UT Location 1

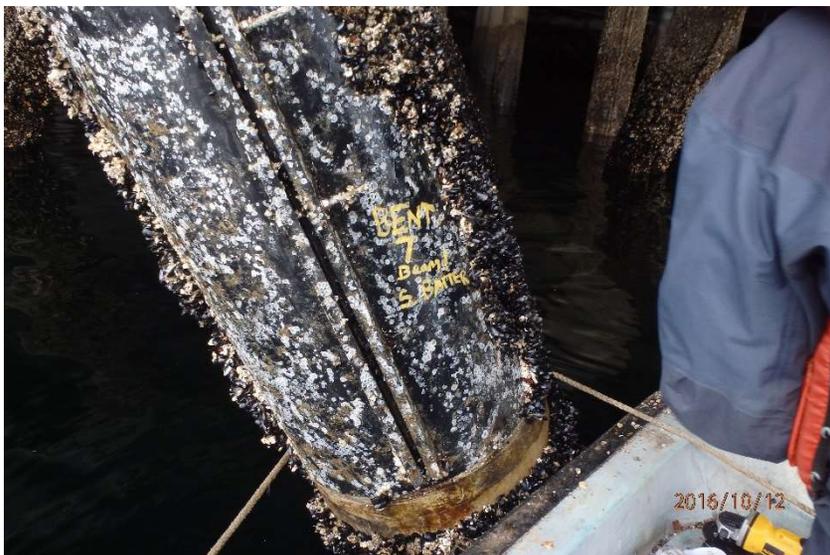
As-found batter pile, south, beneath Beam 1

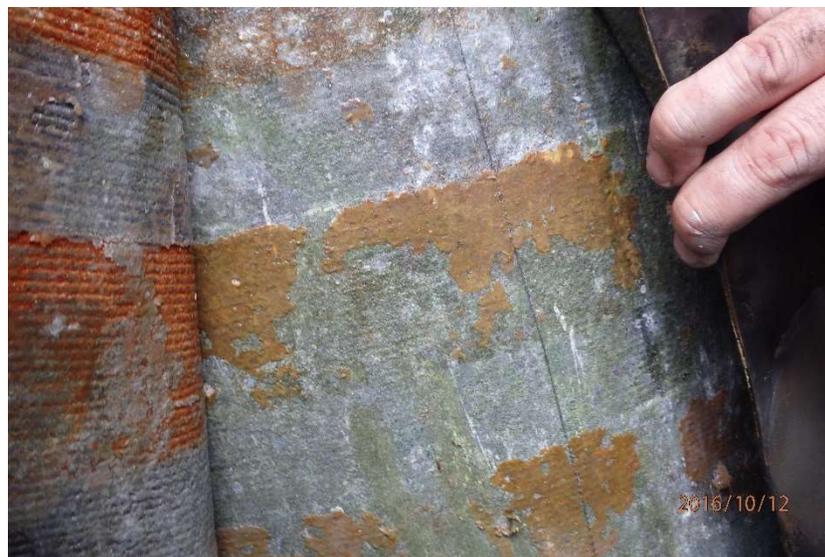
Close-up of piling surface with no visible corrosion

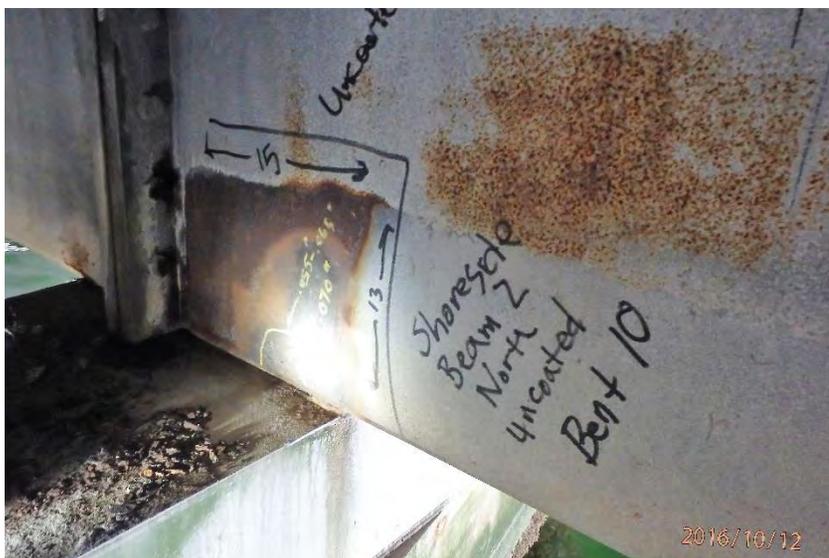
Component	Corrosion Notes	UT Location	UT Readings (mils)		Comments:
Beam 2 shore side, north end	Area is missing coating. Uniform surface corrosion and moderate pitting to 70 mils max depth. Adjacent Coating DFT: 13-28 mils	1. Uncoated area	UT Loc.	AWT	Approximate dimensions of examination area are 15"x13" Nominal Thickness: 438 mils Lowest RWT: 339 mils *Highest corrosion rate found at 9.9 mils per year. Assumes this corrosion has occurred since the 2006 refurbishment*

Beam 2 shore side, north end (UT Location 1)

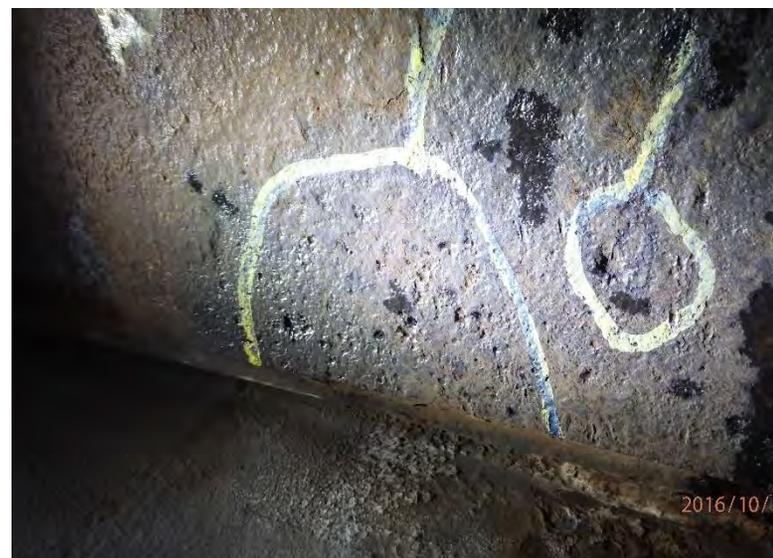
Close-up of UT Location 1

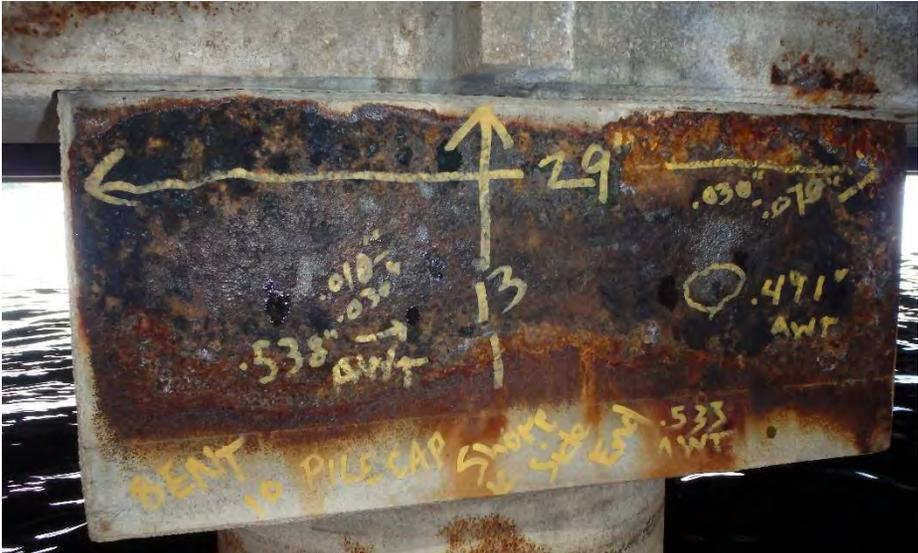
1.	409	
Piling cap sea side end plate	Moderate pitting to 70 mils max depth present. Adjacent Coating DFT: 15-25 mils	2. In area cleared for visual examination on end plate	UT Loc.	AWT	Approximate dimensions of examination area are 29"x13" Nominal Thickness: 500 mils Lowest RWT: 421 mils
			2	491	
Piling 1	Exposed piling steel surface is in good condition. No corrosion visible on piling.	3. N/A	UT Loc.	AWT	Jacket is missing from piling or has slipped down. Some exposed piling surface is covered by remaining tape wrap.
			--	--

Piling cap sea side end plate (UT Location 2)

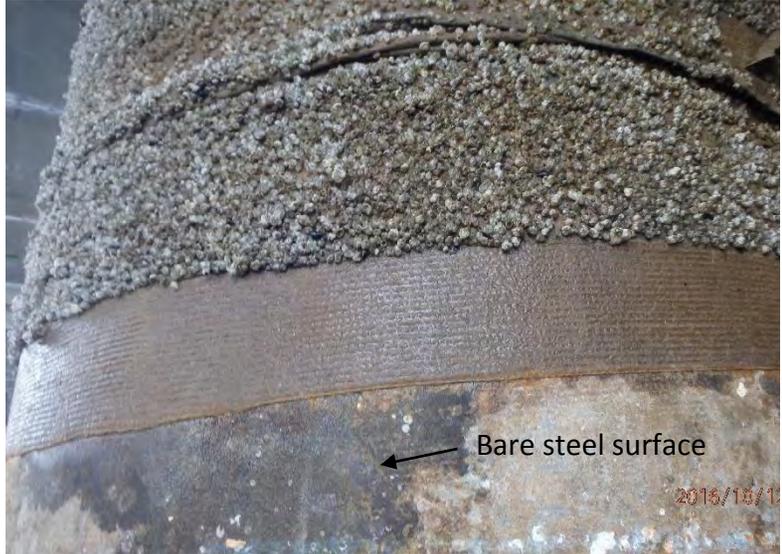
Close-up of piling exposed steel surface

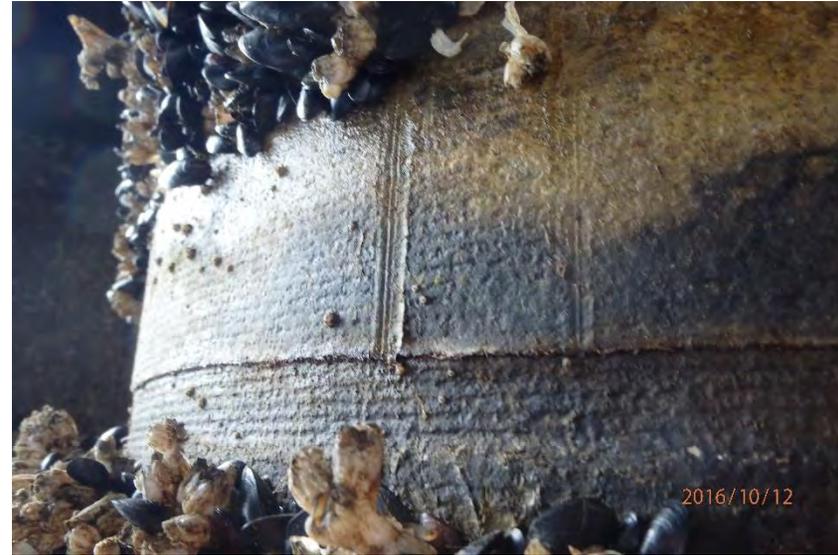
Pile 1, with jacking gap. Tape wrap intact and not removed.

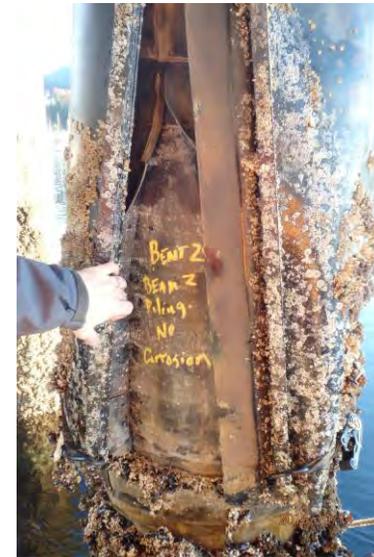
Pile sleeve, no corrosion

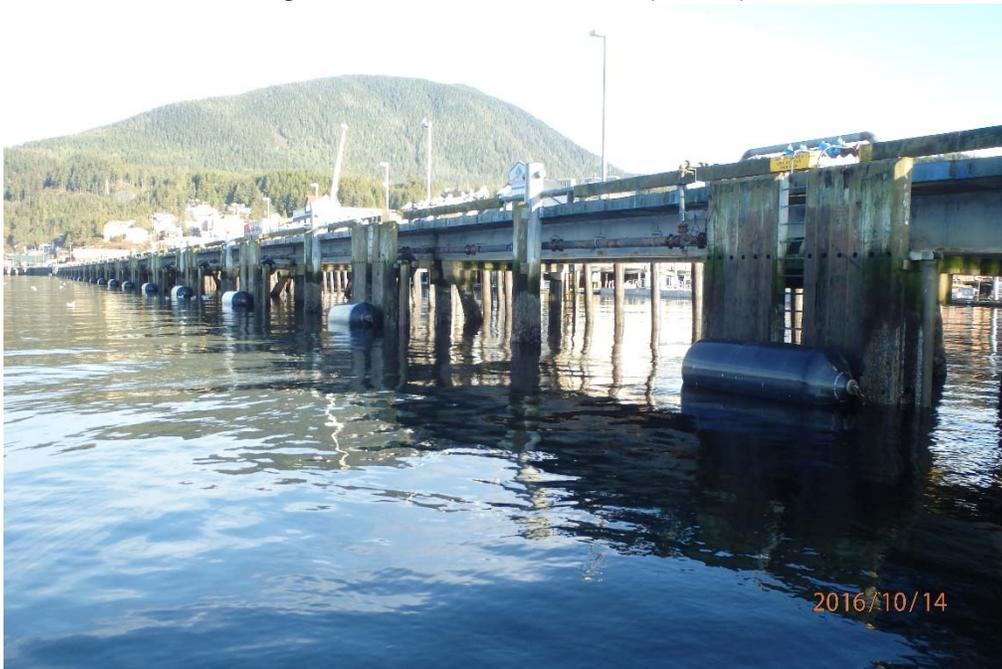
Figure 4: Overview of west side of Berths 1 & 2

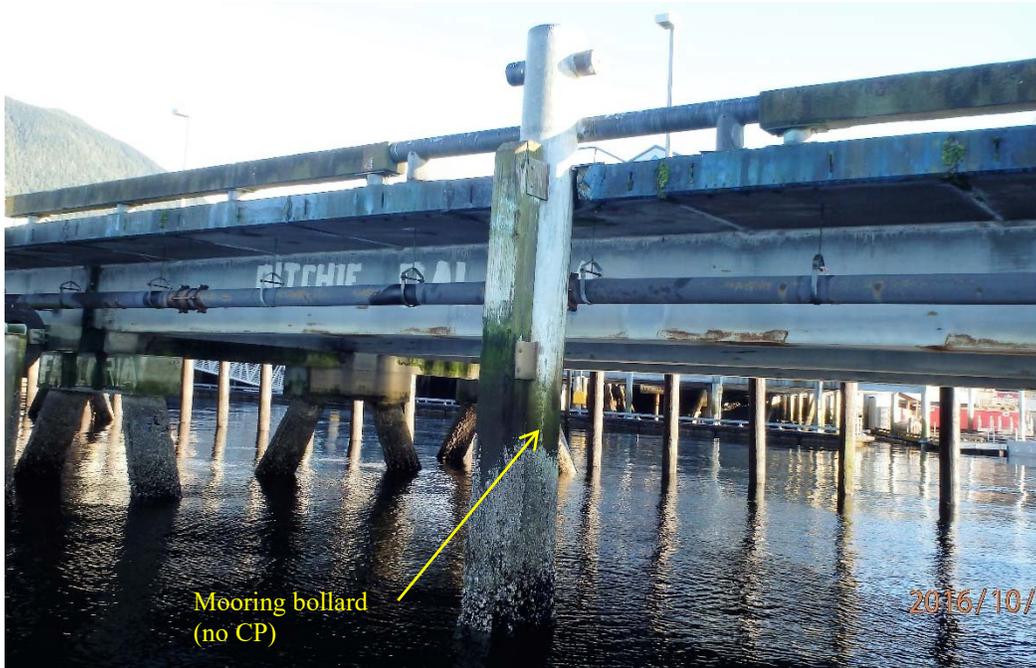
Figure 7: Typical mooring bollard (22 total)

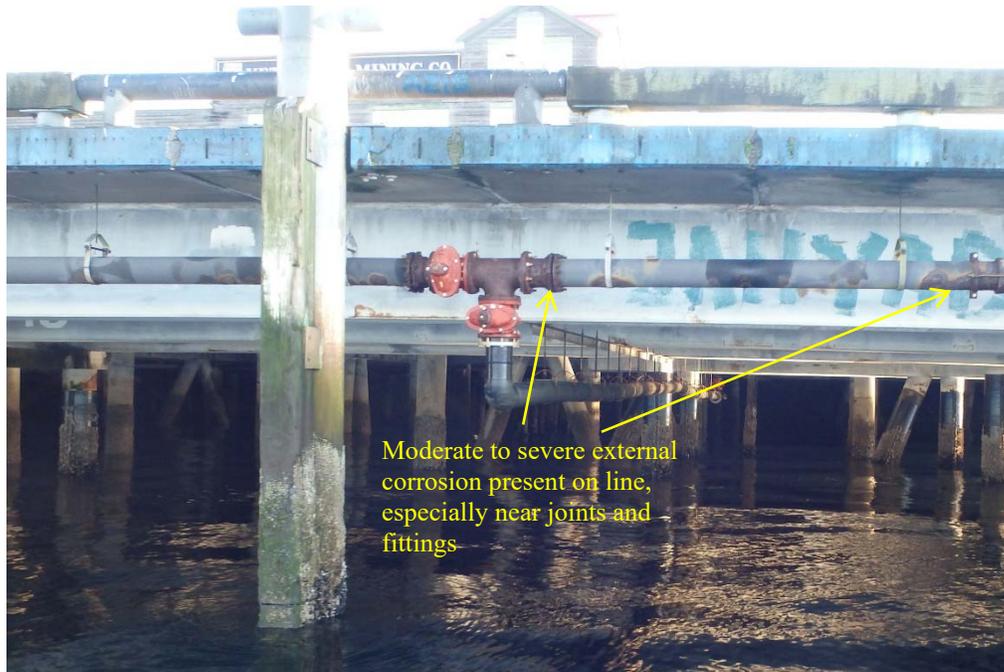
Figure 8: Water line (6") and hanger supports beneath berth

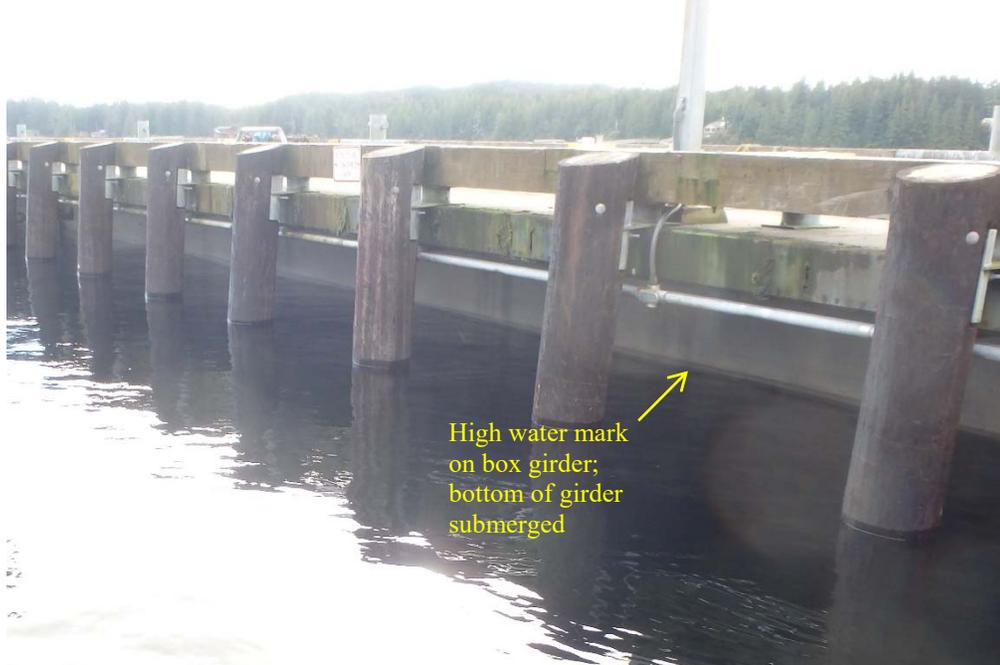
Figure 12: High water mark on box girder (Taken 12:18 on 10/14/16, high tide 16.7 ft)

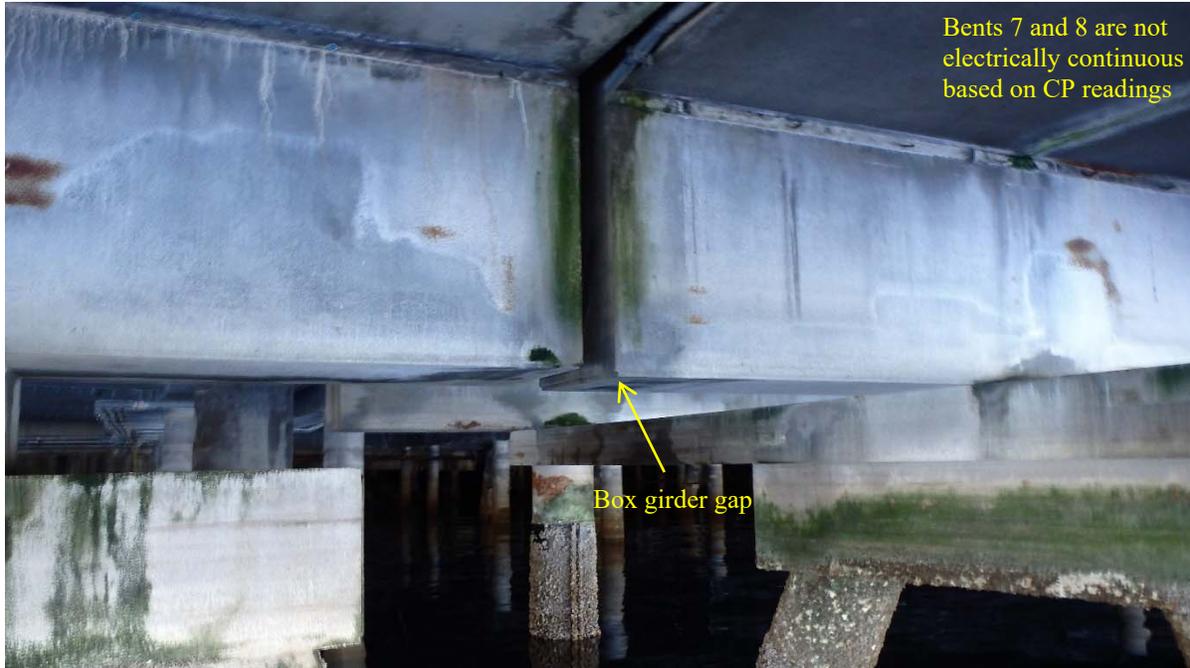
Figure 13: Box girder gap between Bents 7 and 8 (gap present on both box girders)

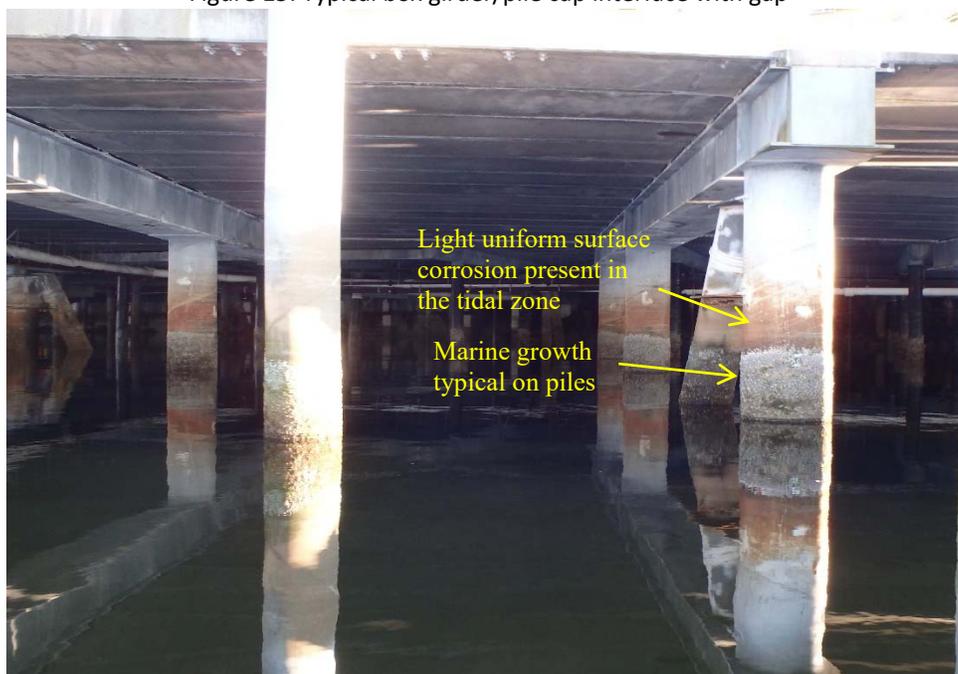
Figure 16: Berth 3 piles overview
